**IN THE UNITED STATES DISTRICT COURT  
FOR THE DISTRICT OF IDAHO**

**DECLARATION OF LAURENCE D.  
ZUCKERMAN**

### **Meyers Cove Exclosure**

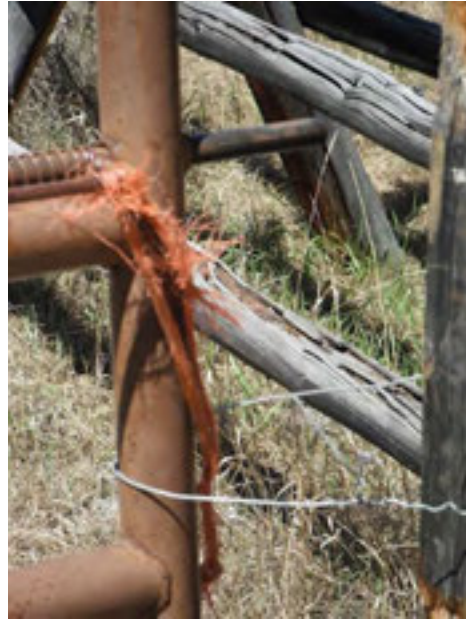
10. On August 2, when I first passed the gate leading through the exclosure at the West Fork ford road, it was closed, but I observed that the gate’s designed closure mechanism was broken and that only a piece of flimsy wire was holding the gate closed. Fig. 1. I was concerned that it could easily dislodge or break. Sure enough, when I passed the gate later in the day on the way out of the allotment, the gate was wide open. Fig. 2.

Fig. 1: Closure mechanism of West Fork gate. August 2, 2012.

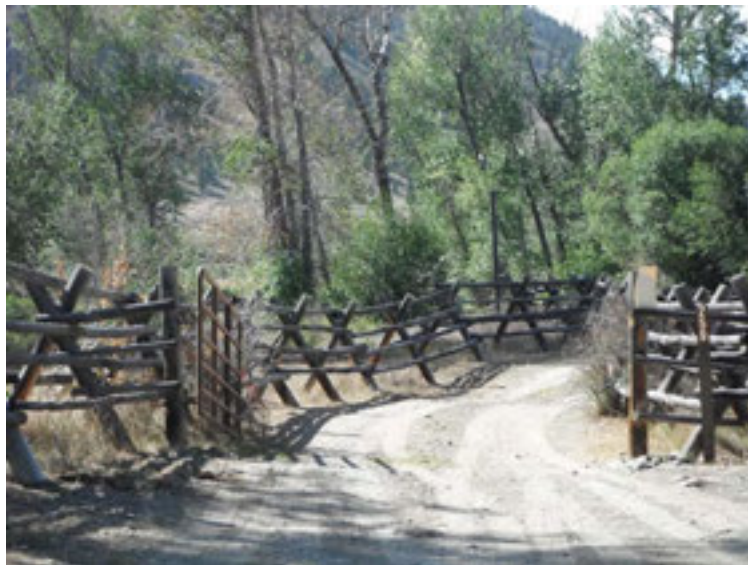
Fig. 2: West Fork gate wide open at end of day. August 2, 2012.

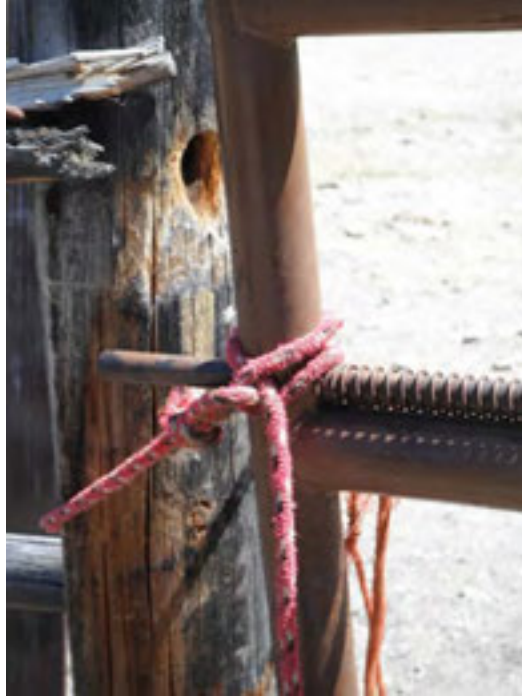
11. On August 11, 2012, the piece of wire had been replaced by another temporary fix, a rope, instead of fixing the actual latch.

Fig. 3: Closure mechanism of West Fork gate. August 11, 2012.

12. This is problematic because cattle entering the West Fork Camas Creek road through the gate can often easily gain entry into the Meyers Cove exclosure and its important spawning habitat. This is because the lightweight drift fencing along the ford is often in disrepair, as described below.

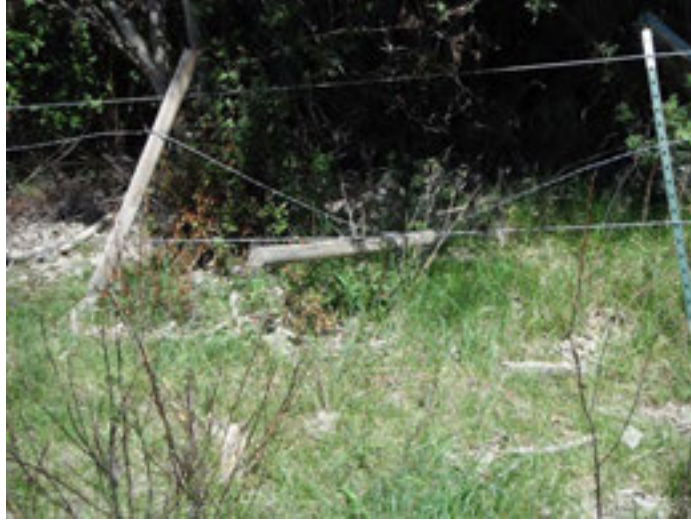
13. On August 11, I observed that the drift fence crossing Camas Creek along the West Fork ford, within the exclosure, was in a poor state of repair, including a downed pole, several broken wires, and sections of both sides of the fence leaning precipitously. Figs. 4–8.

Fig. 4: West Fork ford fence, downstream side of fence, descending right bank.<sup>1</sup> August 11, 2012.

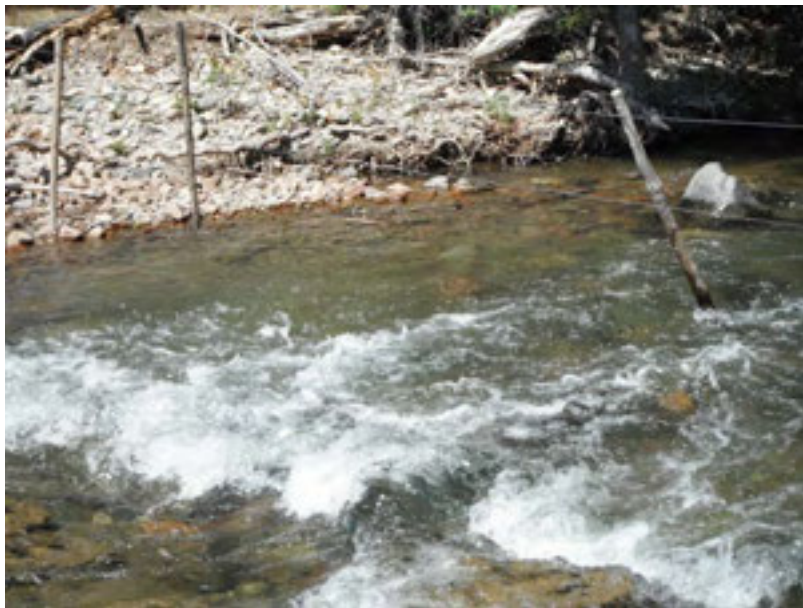
Fig. 5: West Fork ford fence, downstream side of ford, bottom wire missing. August 11, 2012.

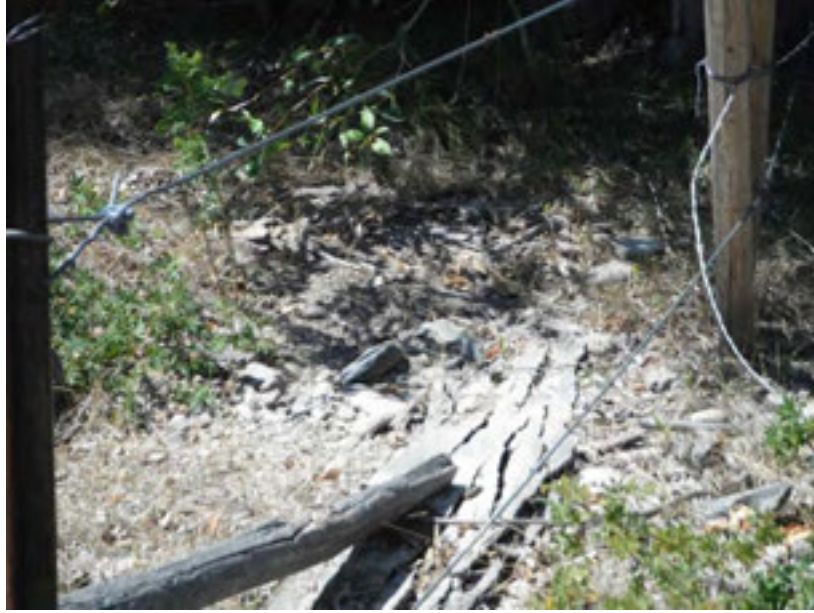
Fig. 6: West Fork ford fence, downstream side of ford, middle wire broken. August 11, 2012.

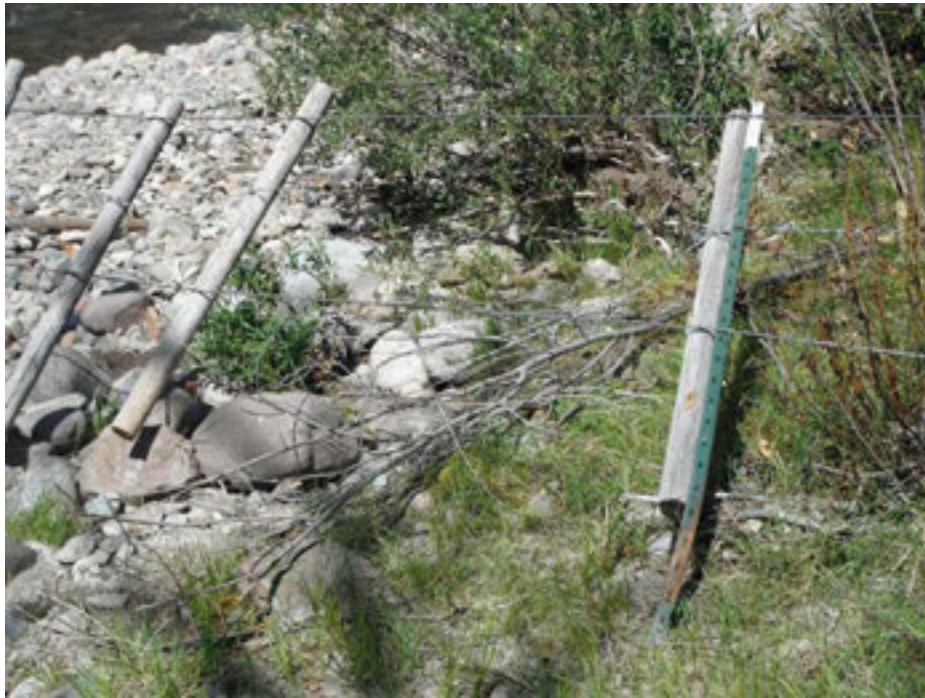
Fig. 7: West Fork ford fence, downstream side of ford, middle wire broken and posts leaning. August 11, 2012.

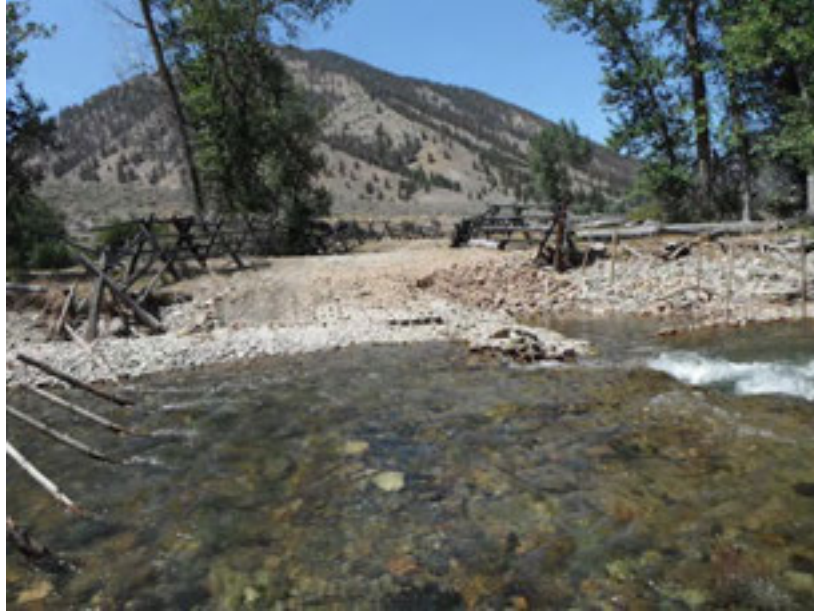
Fig. 8: West Fork ford fence, upstream side leaning precipitously. August 11, 2012.

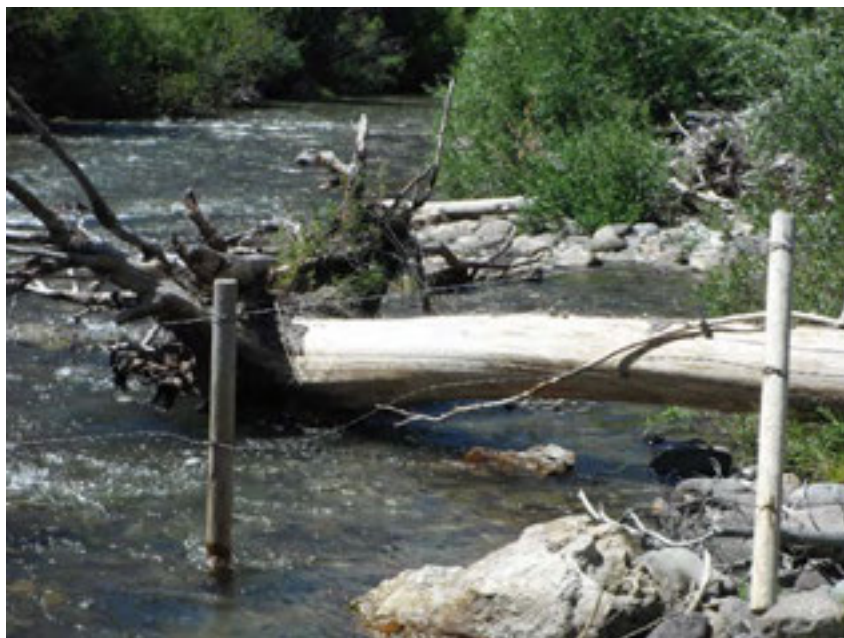
15. On August 2, 2012, I observed that the drift fence crossing Camas Creek on the upstream end of the enclosure was in a poor state of repair, as the bottom wire was broken.

Fig. 9: Enclosure upstream boundary drift fence. August 2, 2012.

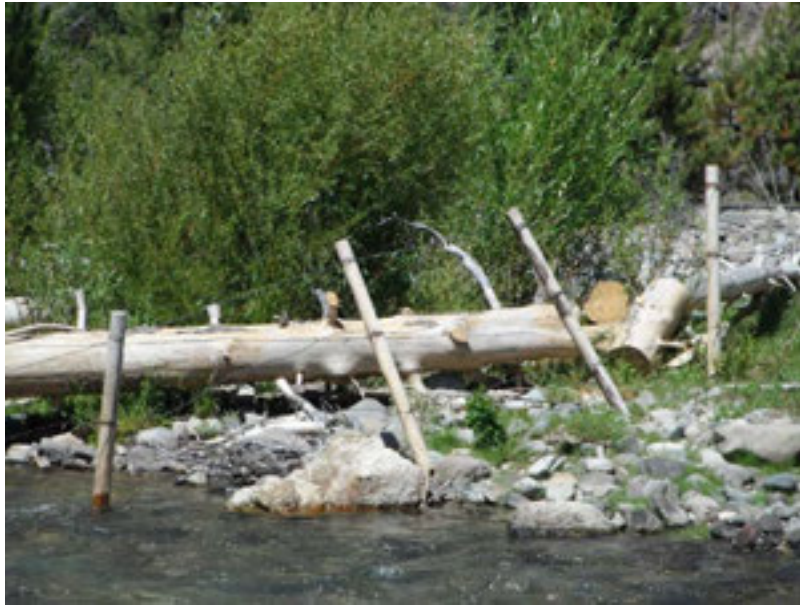
16. The bottom wire was still broken and other wires were loose on August 11, 2012.

Fig. 10: Upstream drift fence. August 11, 2012.

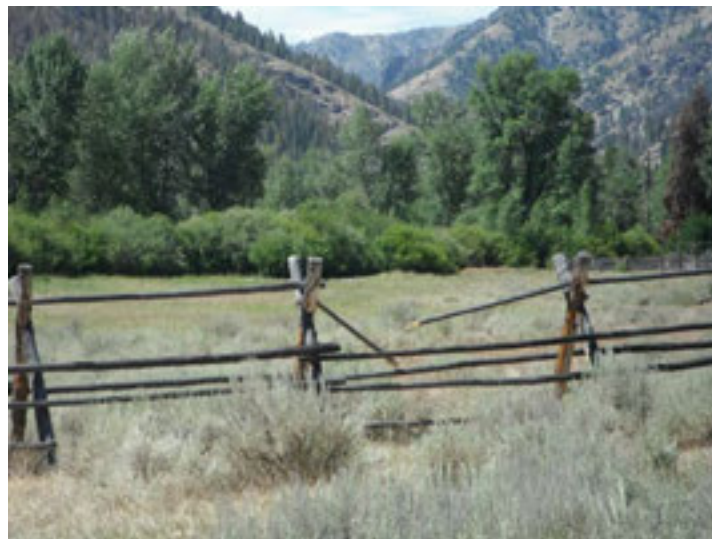
17. On August 2 and all my visits thereafter, I observed several downed poles and other gaps in the buck and pole fence surrounding much of the enclosure.

Fig. 11: Downed pole in enclosure fence. August 2, 2012.

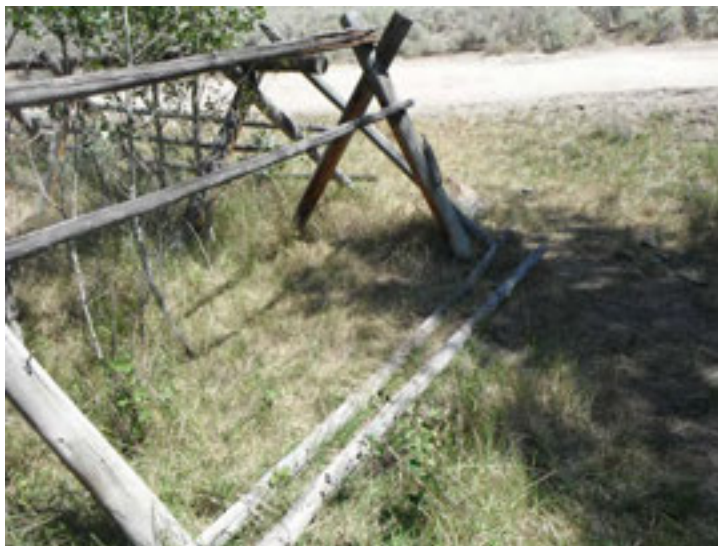
Fig. 12: Downed pole in exclosure fence. August 2, 2012.

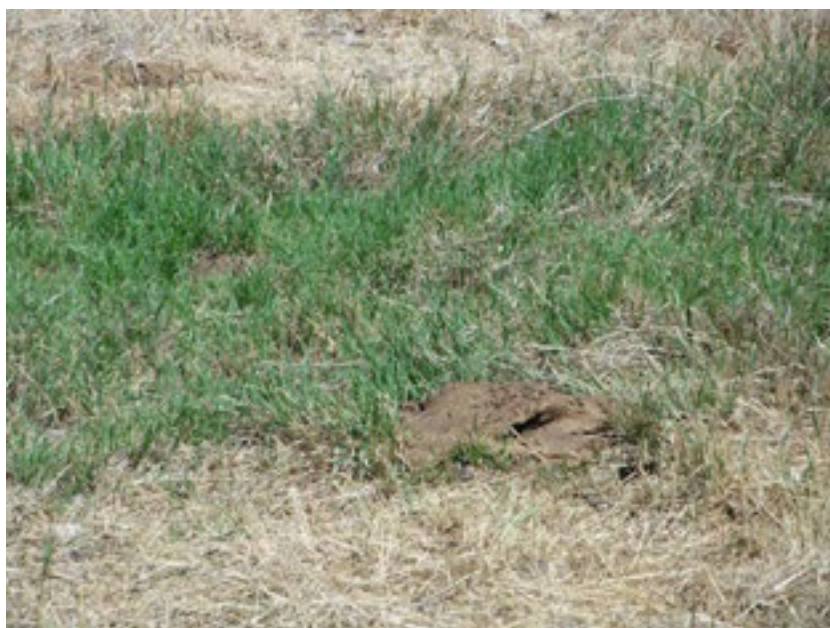
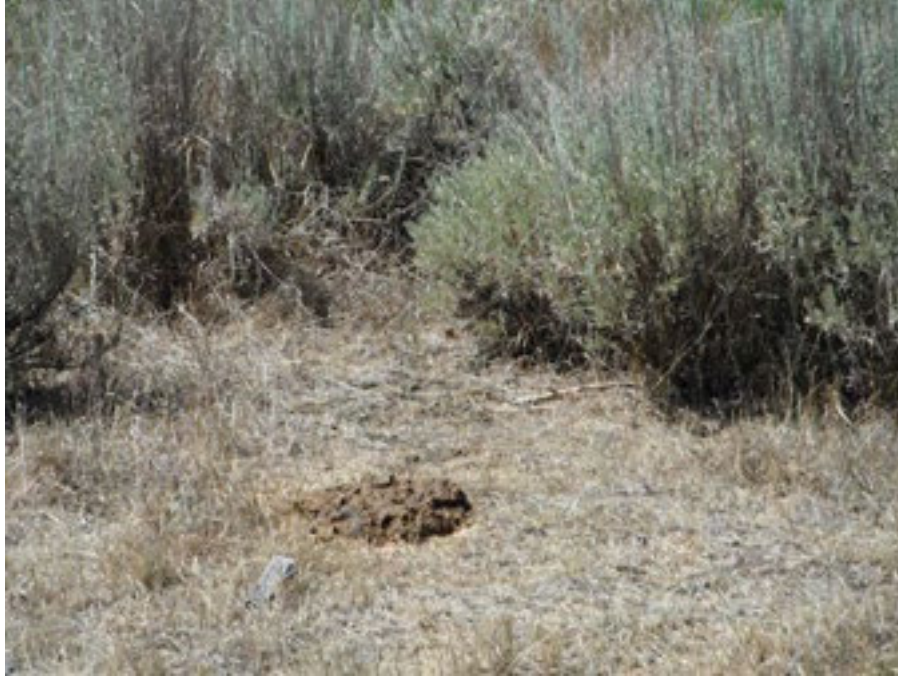
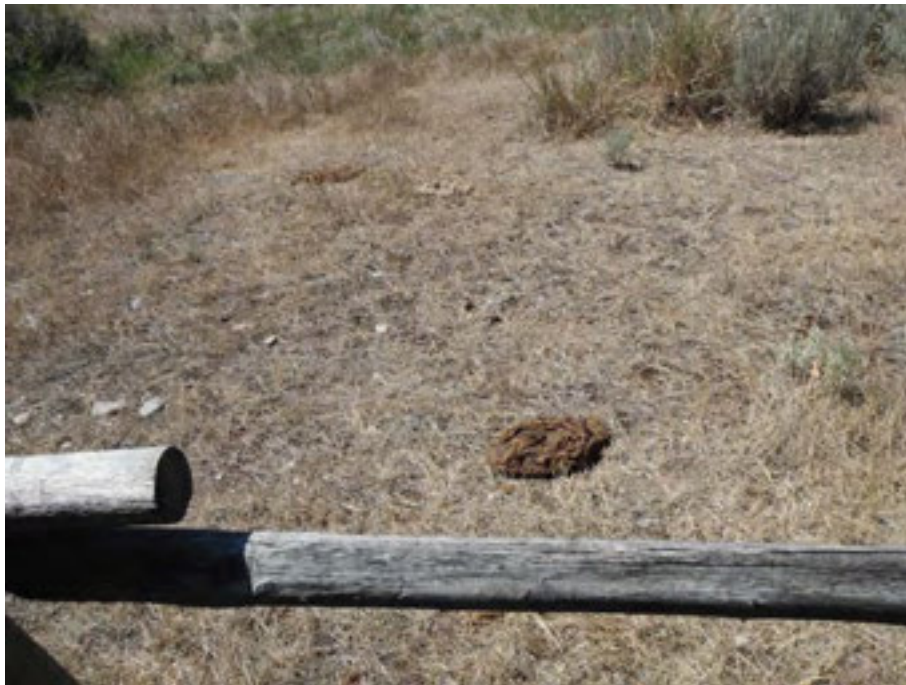
18. On both August 2 and 11, I observed abundant signs of cattle use, including bank trampling, defecation, and browsing of woody riparian bushes and trees inside the Meyers Cove exclosure. This included dozens of cow pies that appeared to be from this season. Since the allotment was not grazed in 2011, any cow pies that were dark and relatively fresh had to have come from this year, as all others would be two years old or older.

Fig. 13: Fresh cow waste inside Meyers Cove exclosure. August 11, 2012.

Fig. 14: Fresh cow waste inside Meyers Cove exclosure. August 11, 2012.

Fig. 15: Fresh cow waste inside Meyers Cove exclosure. August 11, 2012.

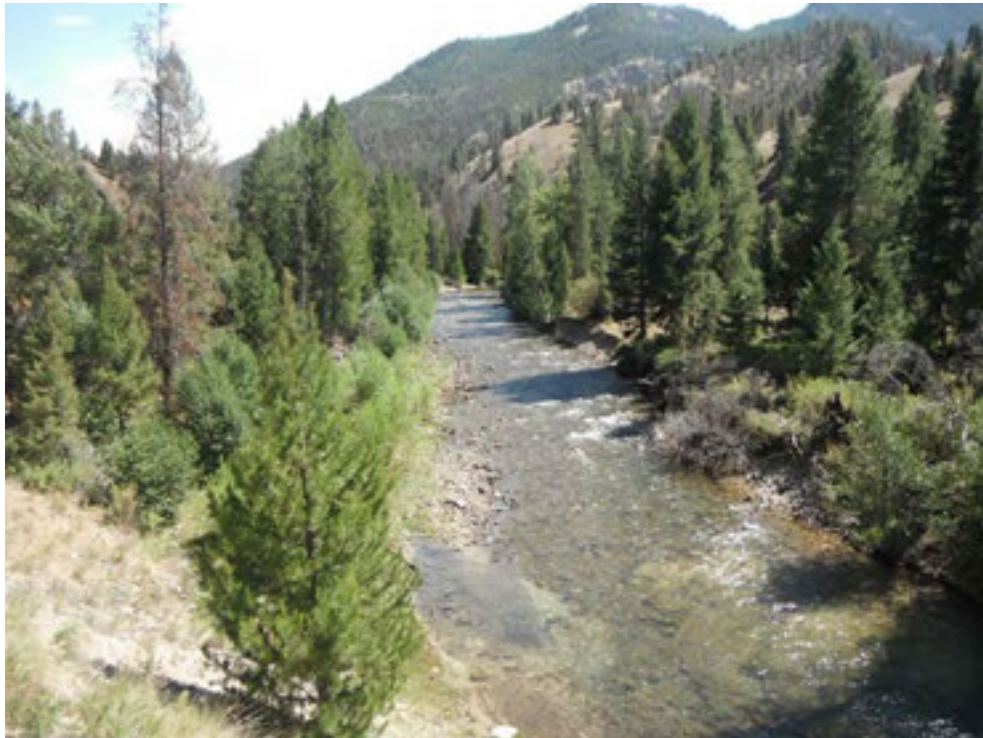
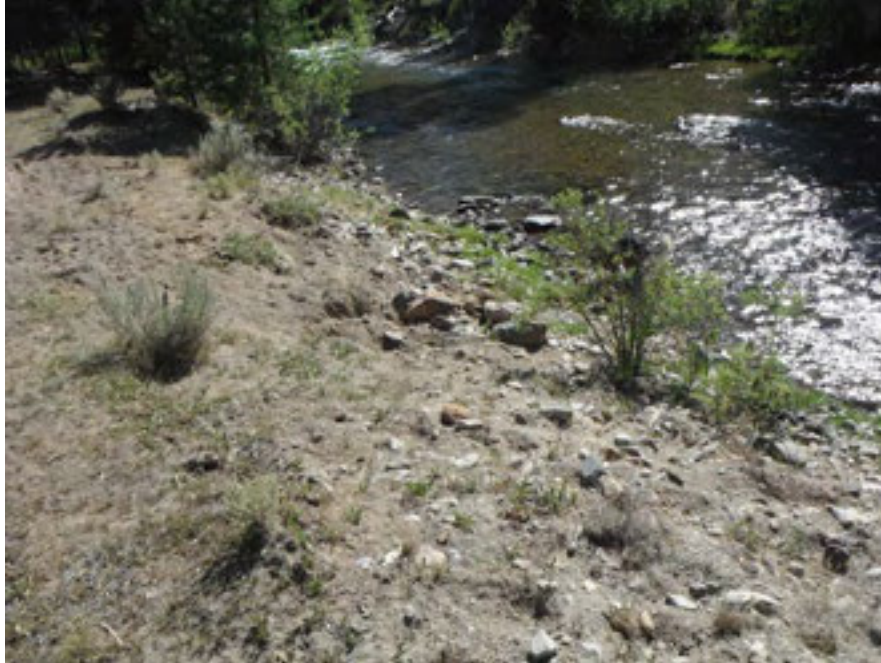
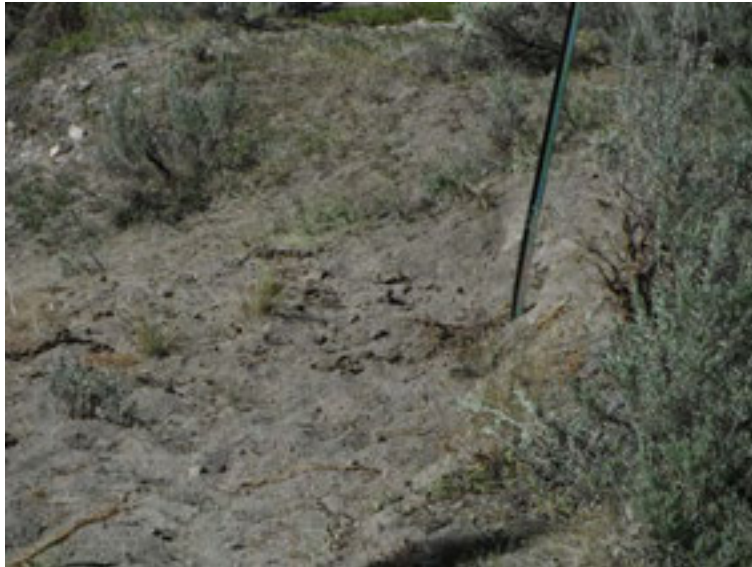
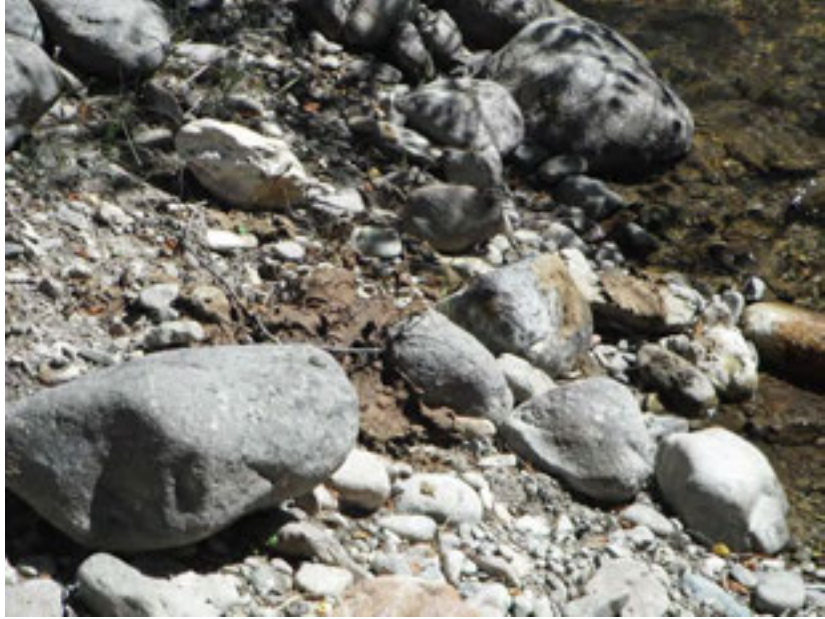
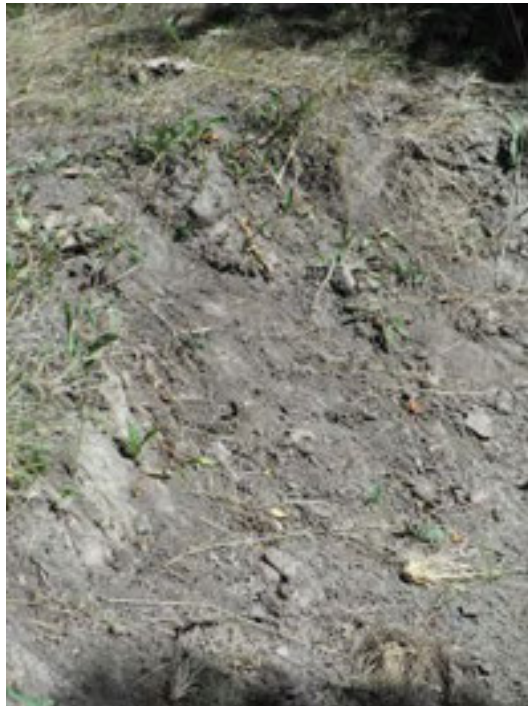
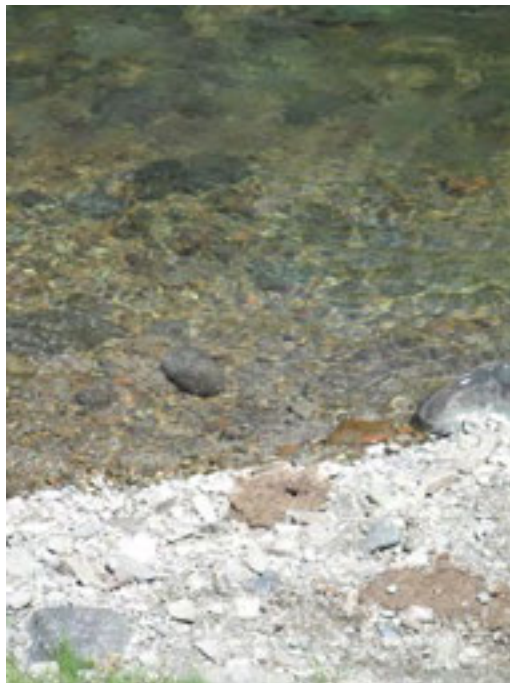
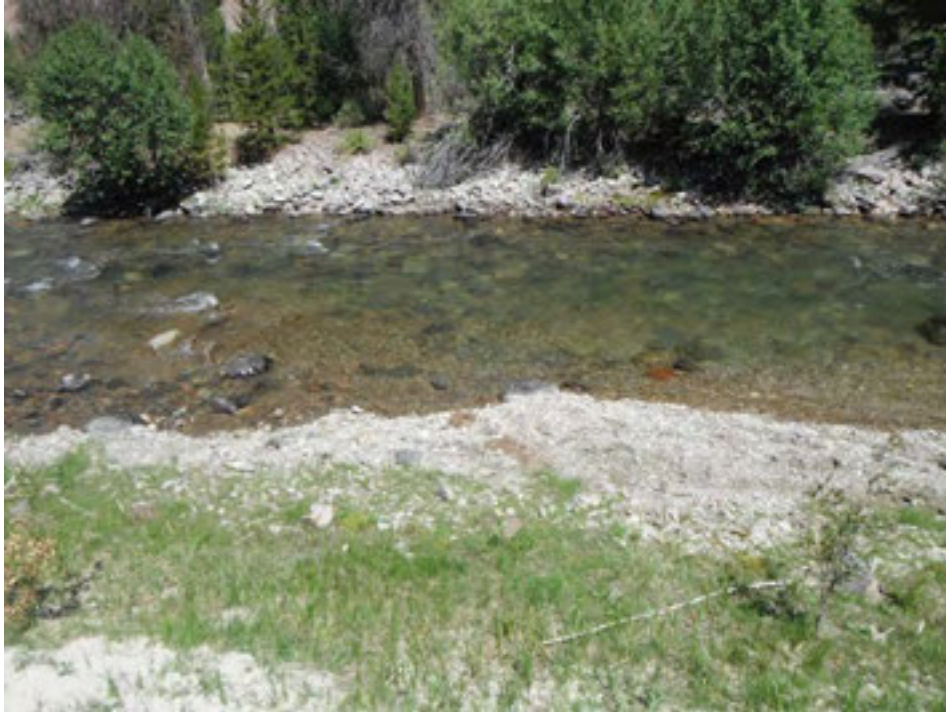
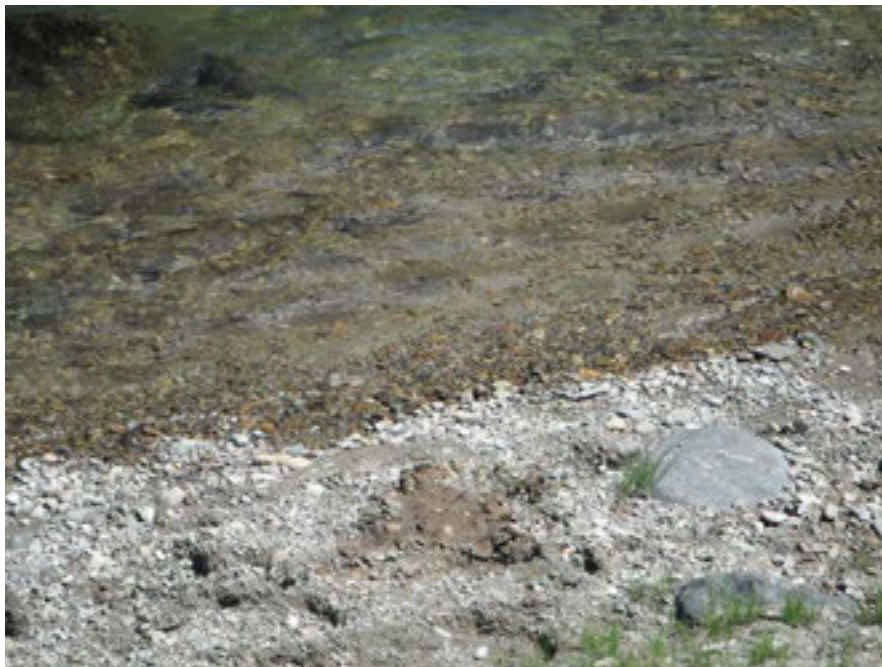
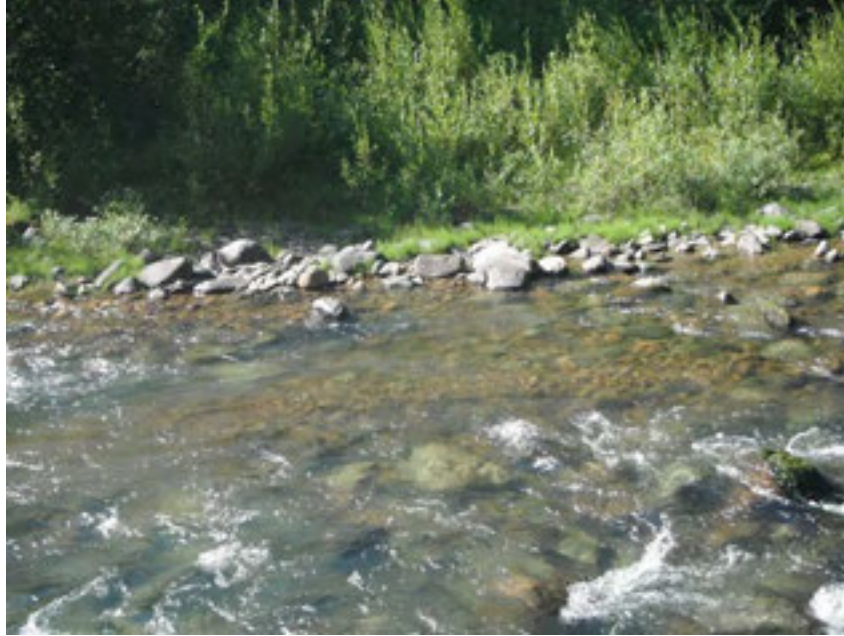
20. I walked along this reach for several kilometers on August 2 and August 11, and observed recent cattle sign on both banks of this reach of Camas Creek that supports spawning. I also drove the left bank on subsequent trips and stopped and inspected the creek.

Fig. 16: Overview of Camas Creek reach upstream of Meyers Cove enclosure, looking upstream. August 2, 2012.

Fig. 17: Recently used cattle trail along right bank of Camas Creek, above Meyers Cove exclosure. August 2, 2012.

Fig. 18: Recently used cattle trail along right bank of Camas Creek, above Meyers Cove exclosure. August 2, 2012.

Fig. 19: Fresh cattle waste along right bank of Camas Creek, above Meyers Cove enclosure. August 2, 2012.

Fig. 20: Actively eroding, trampled right bank of Camas Creek, above Meyers Cove enclosure. August 2, 2012.

Fig. 21: Fresh cattle waste along left bank of Camas Creek, above Meyers Cove exclosure. August 2, 2012. This site was adjacent to suitable salmonid spawning habitats.

Fig. 22: Fresh cattle waste along left bank of Camas Creek, above Meyers Cove exclosure. August 11, 2012.

Fig. 23: Fresh cattle waste (appeared to be less than a week old) along left bank of Camas Creek, above Meyers Cove exclosure. August 11, 2012.

Fig. 24: Fresh cattle waste (appeared to be less than a week old) and recent hoof prints on left bank of Camas Creek, above Meyers Cove exclosure. August 11, 2012.

Fig. 25: Chinook salmon redd in Camas Creek, above Meyers Cove exclosure, in an area with sign of cattle access. August 11, 2012.

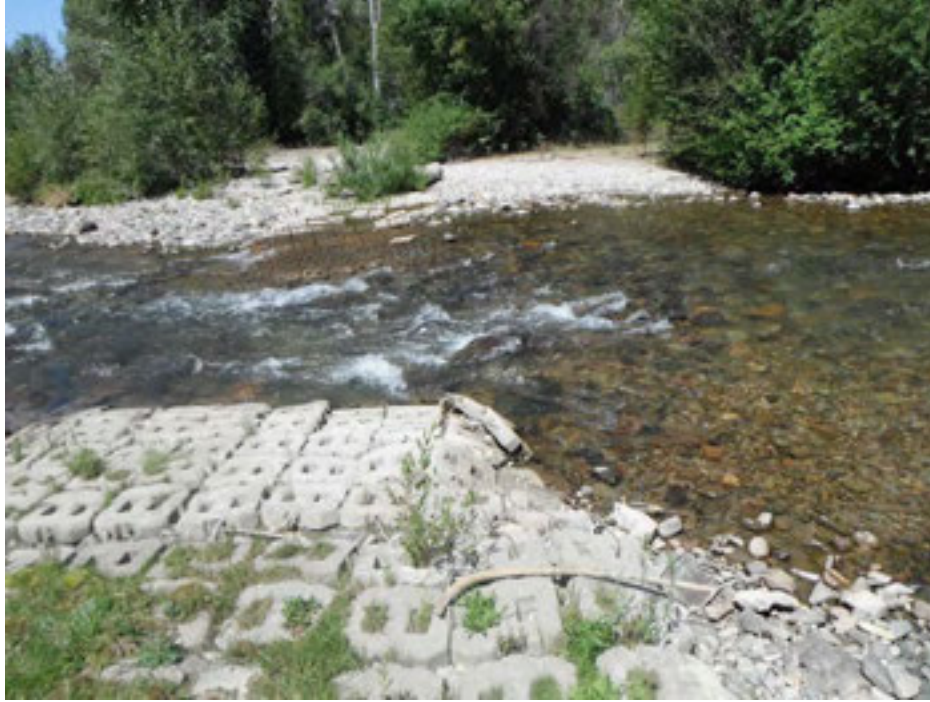
21. On several of my visits, I observed and crossed Camas Creek ford #3, which is near the confluence of Castle Creek and Camas Creek. This ford poses a risk for spawning salmonids, as well as incubating eggs and in-gravel developing alevins, because the paving blocks have washed away in the middle of the stream channel, and are piled high on each side of the channel, making them impassable to many vehicles. This forces vehicles (and likely cows) using the ford to cross upstream of the pavers, over the natural streambed, which contains potential spawning habitat (natural cobble and gravel, low stream gradient, shallow). This means that redds could be built in the ford, which would quickly be crushed by vehicle or cow traffic. This is not a recent development and has been the case since my initial visits to the Camas Creek Allotment in 2003. As the formerly stabilized fords revert to natural conditions, spawning salmonids are drawn back to historic spawning sites, placing them in harm's way.

Fig. 26: Camas Creek ford #3 (near confluence with Castle Creek). Traffic drives on right side of photo, not on the pavers. August 11, 2012.

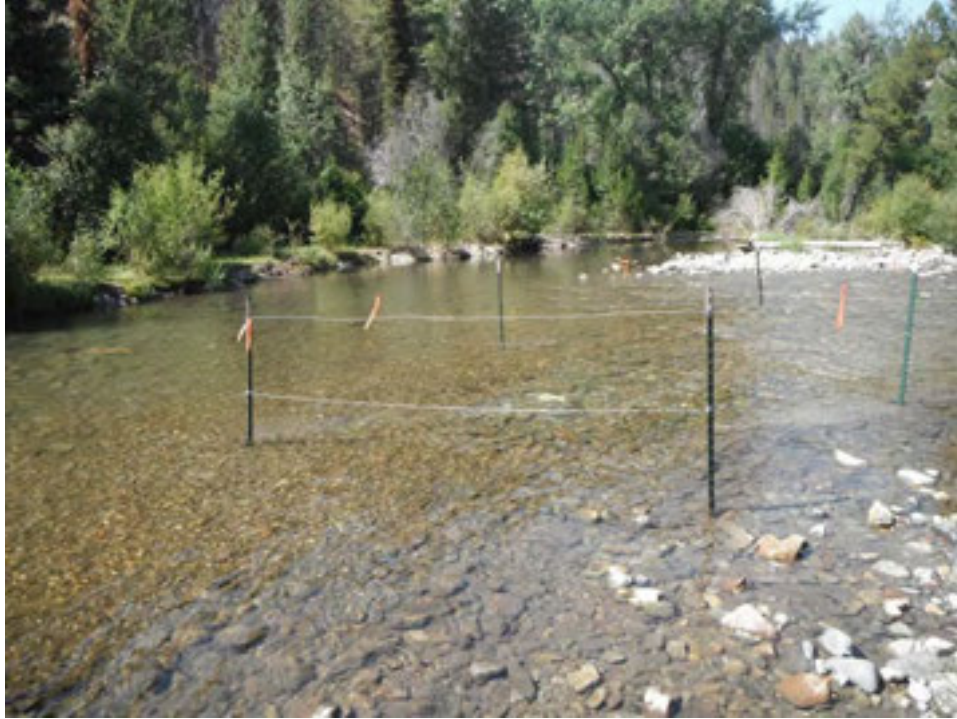
22. On September 4, someone had constructed a miniature exclosure fence within Camas Creek just downstream of ford #3, around a fresh Chinook salmon redd, demonstrating that the ford area is indeed suitable spawning habitat. Presumably the fence was designed to prevent cattle crossing the ford from straying a bit downstream or coming off the adjacent Castle Creek road and trampling the redd.

Fig. 27: Miniature exclosure around Chinook salmon redd, Camas Creek, just below ford #3, along the right bank. September 4, 2012.

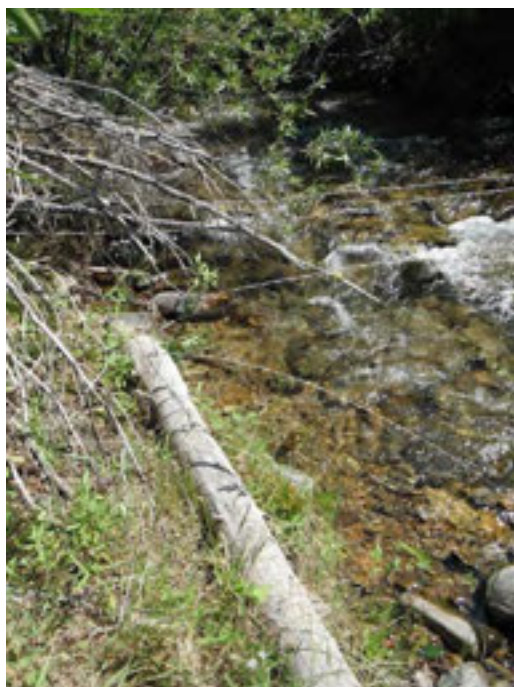
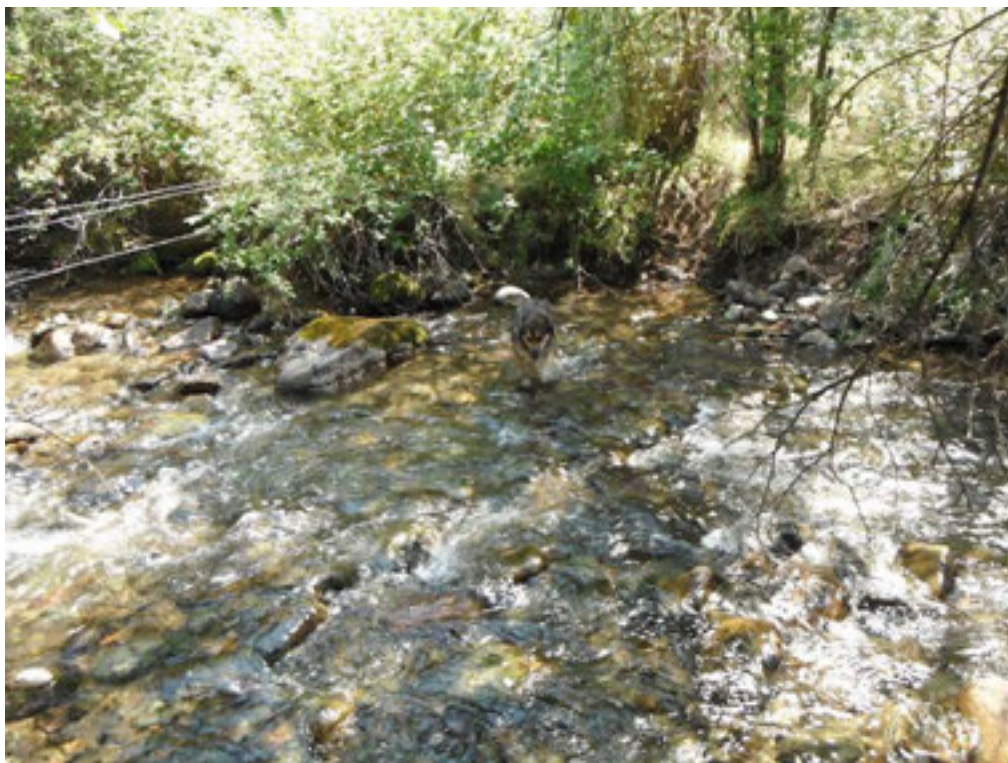
23. On August 17, I drove to the Castle Creek drift fence, which I understand is designed to prevent cattle from moving into the lower mile of Castle Creek, which is spawning habitat for Chinook salmon, steelhead, and bull trout. I hiked along the fence to the creek and observed that the bottom wire of the drift fence was broken, making it easy for cows and calves to get underneath, and that other wires were loose. I visited here again on August 23 and September 4, and the fence was in the same condition.

Fig. 28: Broken, loose wires on Castle Creek drift fence, across Castle Creek. August 17, 2012.

Fig. 29: German Shepherd-Husky mix easily walking under Castle Creek drift fence. August 17, 2012.

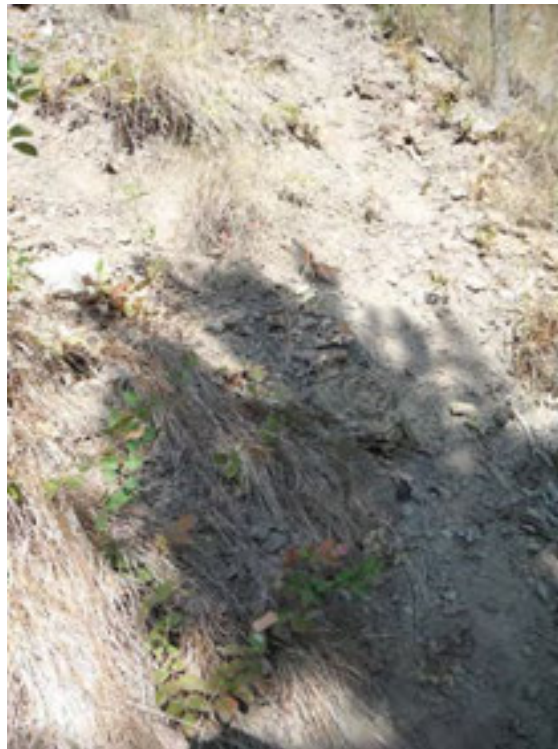
25. On both August 17 and August 23, there were visible cow trails along the downstream side of the drift fence (the side cows are supposed to be excluded from), and I observed cattle sign on both sides of the fence, including manure (both this season's and older), cow trails, hoof prints, and bare ground.

Fig. 30: Cow trail along downstream side of Castle Creek drift fence. August 17, 2012.

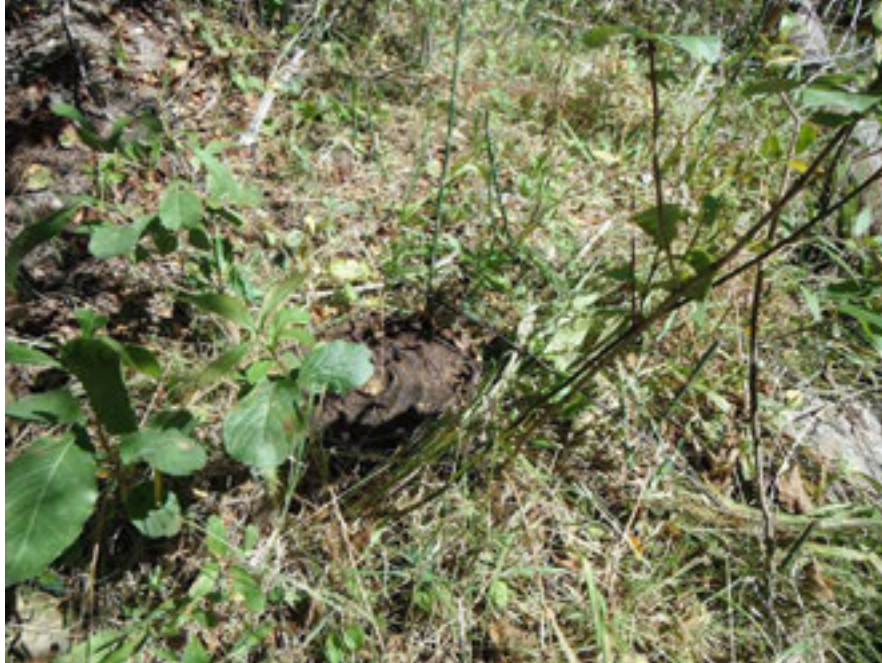
26. On September 4, I observed new, fresh sign of cattle below the drift fence that had not been there in previous weeks. Cow use seemed more recent downstream of the drift fence than upstream. Specifically, I observed fresh cattle waste along Camas Creek below the drift fence. Therefore, I believe cows had been there between August 23 and September 4.

Fig. 31: Fresh cow pie in Castle Creek riparian area, downstream of drift fence. September 4, 2012.

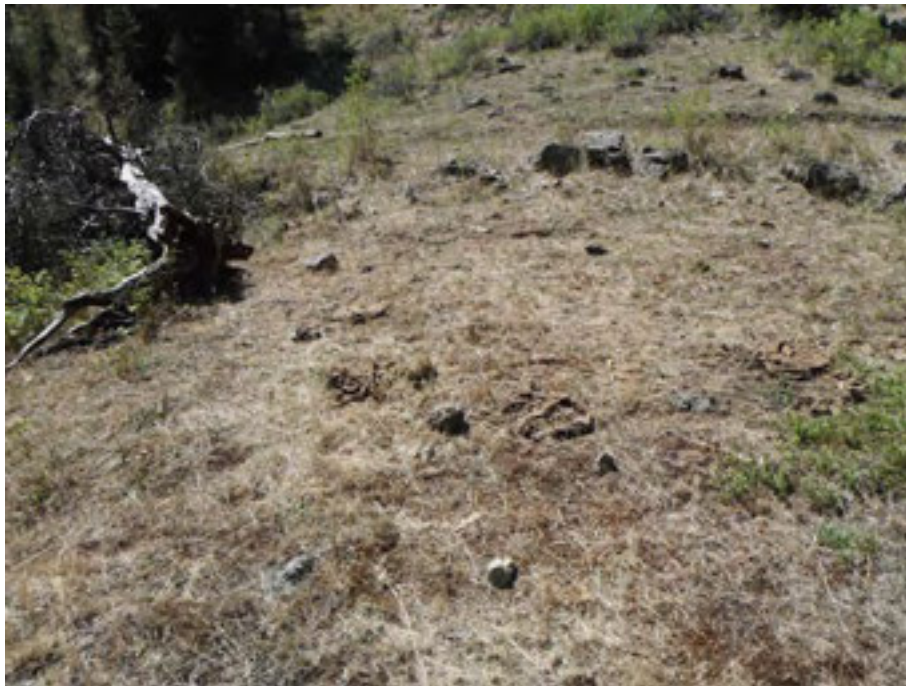
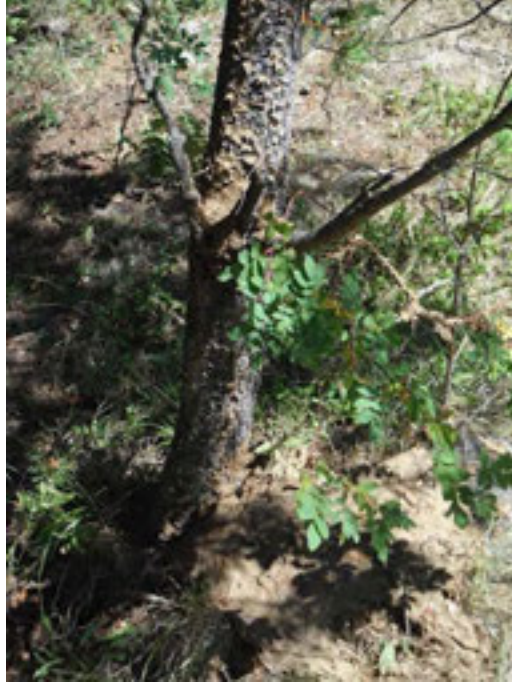
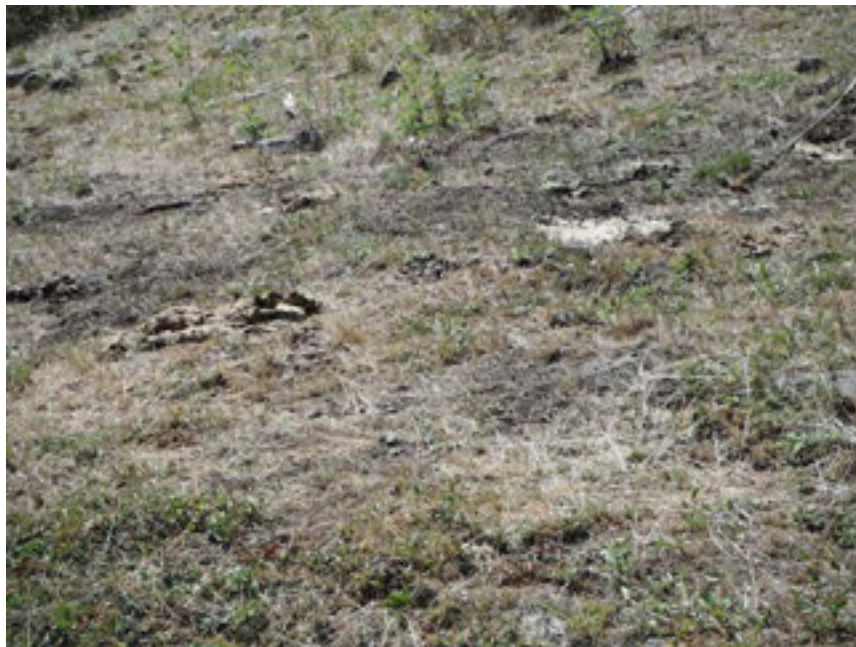
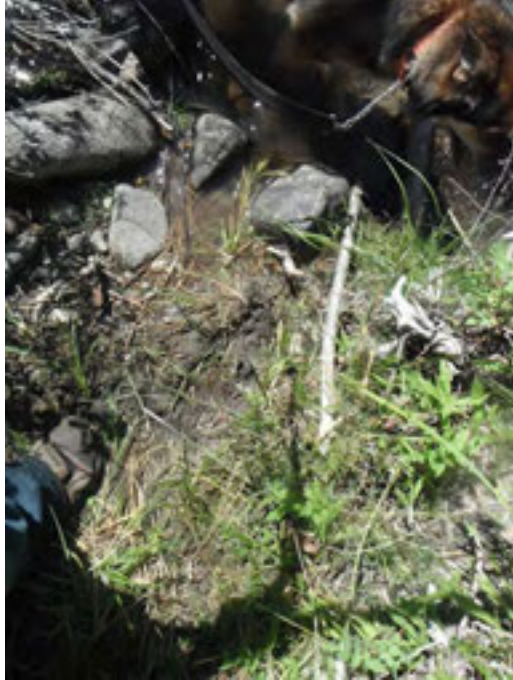
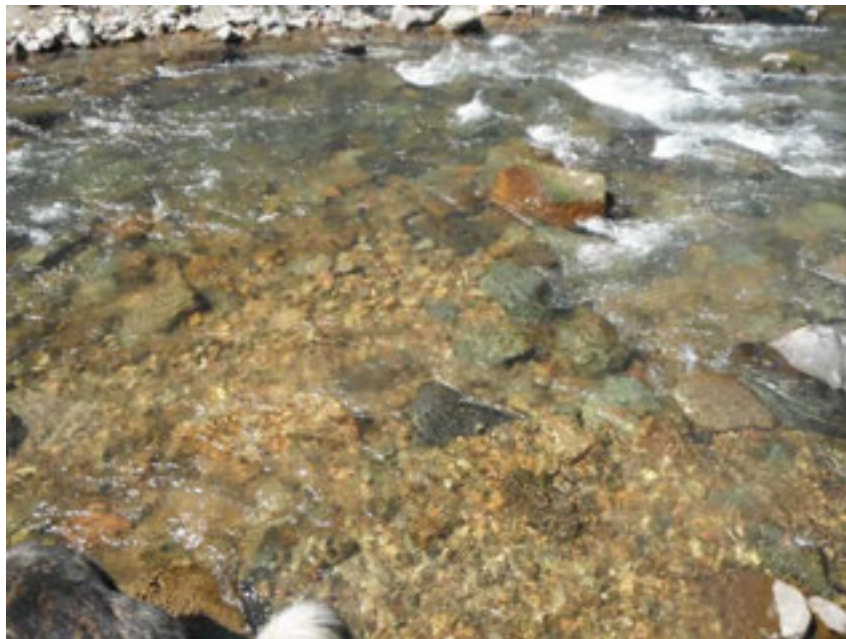
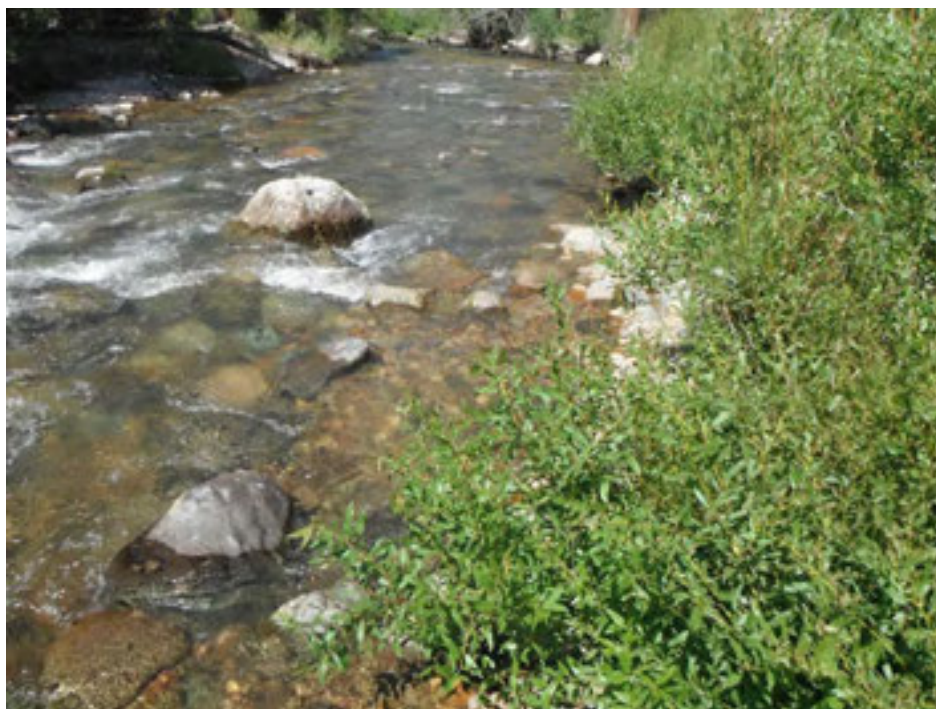
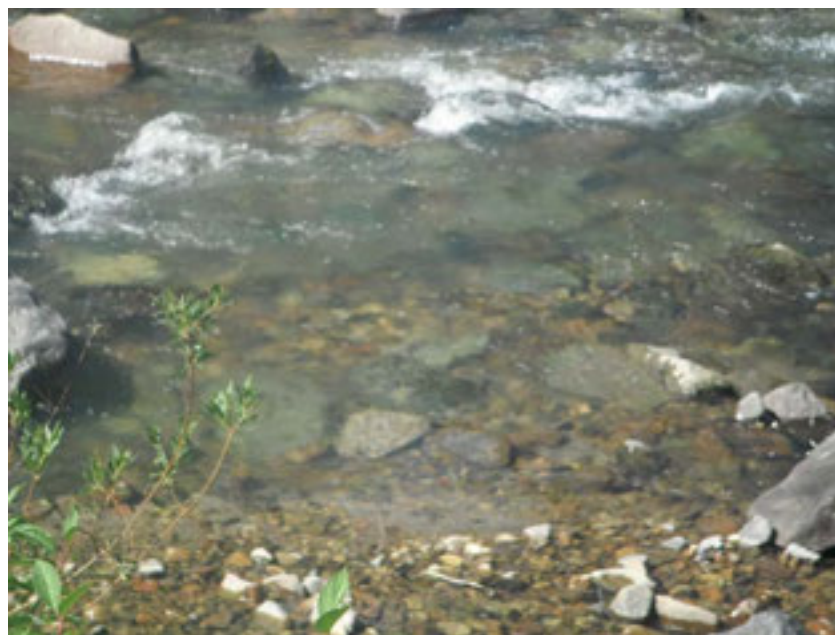
28. For example, on August 11, I walked this reach and observed several recent Chinook salmon redds. The bright, clean gravel and cobble of the redds showed that they had been built in the last week or two. (Older redds start to accumulate some silt, algae, and other debris as time progresses.) I observed signs that cattle were accessing the creek on virtually every flat, open area along the creek that I inspected, including in the same vicinity as the redds.

In fact, I observed that the areas with redds and the areas of cattle access were closely associated, as the redds were found in the flatter, low-velocity sections of the creek, which tended to be the more open, meadow areas favored by cows. Cattle avoided entry where mature willows and woody slash were thick, but found easier ways to the creek. Once at the creek, there was evidence that cattle had moved up and down the banks, as well as crossed the creek (i.e., there was also evidence of cattle on the far side of the creek). In contrast, areas that are more canyon-like with larger boulders, steeper gradients, and faster, deeper runs are both less suitable for spawning and harder for cattle to access.

Fig. 32: Cattle waste in a riparian meadow along the right side of Camas Creek between Castle and Furnace Creeks, near a Chinook salmon redd. August 11, 2012.

Fig. 33: Cattle waste in riparian area of Camas Creek between Castle and Furnace Creeks. August 11, 2012.

Fig. 34: Riparian meadow littered with cattle waste along Camas Creek, between Castle and Furnace Creeks. August 11, 2012.

Fig. 35: Fresh cattle hoof print on Camas Creek, adjacent to prime salmonid spawning habitat with active redds in sight, between Castle and Furnace Creeks. August 11, 2012.

Fig. 36: Cleaned gravel in a raised pocket (center of photo) in Camas Creek indicates Chinook salmon redd building activity, between Castle and Furnace Creeks. Cattle access nearby. August 11, 2012.

Fig. 37: Chinook salmon redd in Camas Creek, between Castle and Furnace Creeks. August 11, 2012.

Fig. 38: Chinook salmon redd in Camas Creek, adjacent to banks and riparian areas with cattle sign, between Castle and Furnace Creeks. August 11, 2012.

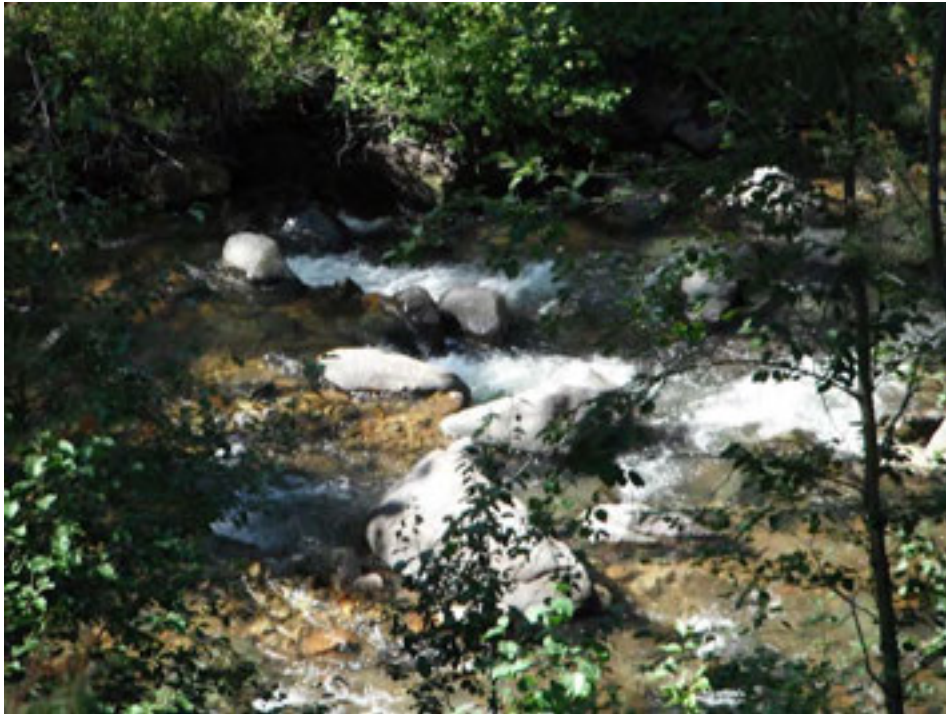
additional fresh Chinook salmon redd, along with the same pattern use and new cattle sign in the vicinity.

Fig. 39: Chinook salmon redd in Camas Creek between Castle Creek and Furnace Creek. August 17, 2012. Cattle sign in the vicinity along right bank of Camas Creek.
