**IN THE UNITED STATES DISTRICT COURT  
FOR THE DISTRICT OF IDAHO**

**DECLARATION OF LAURENCE D.  
ZUCKERMAN**

### **Meyers Cove Exclosure**

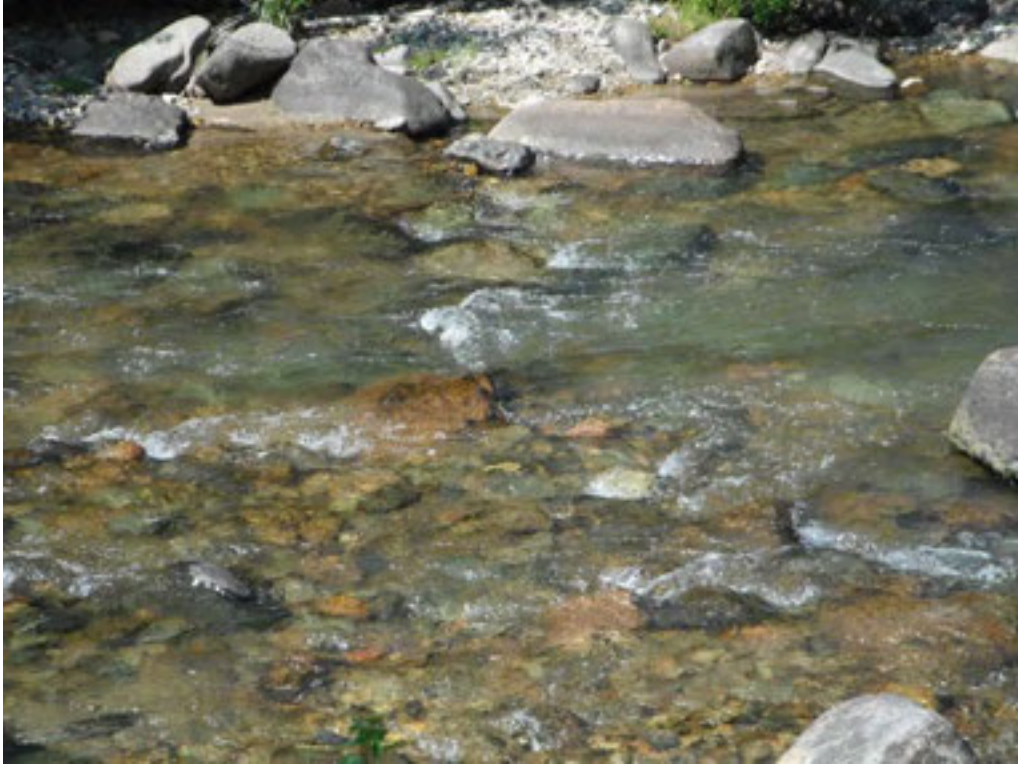
30. I again hiked this reach on August 23, and observed several additional fresh Chinook salmon redds, including one reach with three new redds in a row from upstream to downstream.

Fig. 40: Chinook salmon redd in Camas Creek between Castle and Furnace Creeks. Cattle access nearby. August 23, 2012.

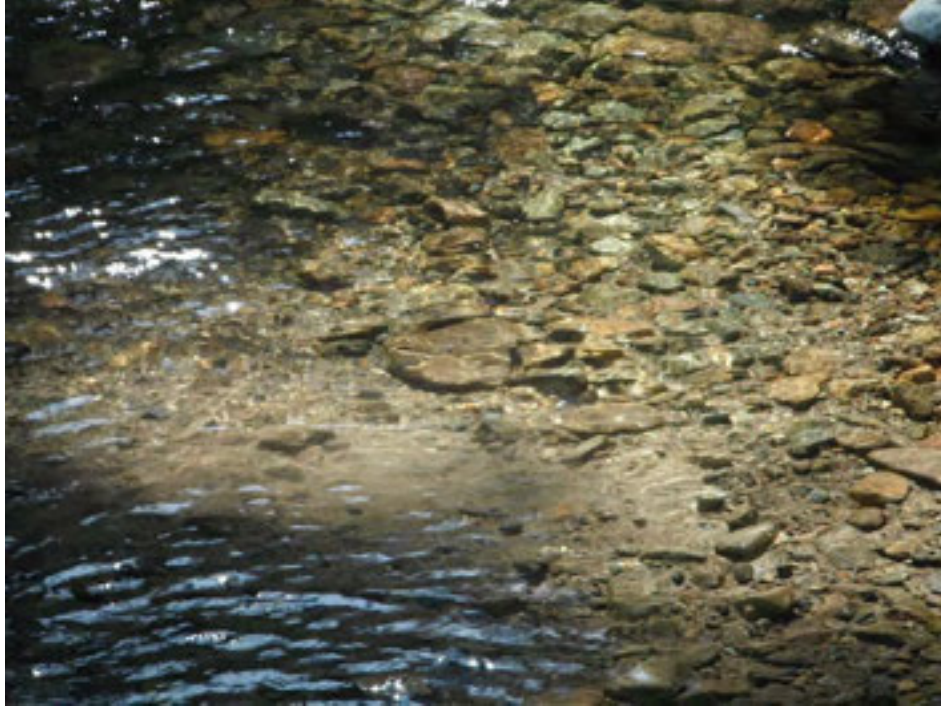
31. I again hiked this reach on September 4, and observed several additional fresh Chinook salmon redds, with evidence of cattle reaching the creek near this site.

Fig. 41: Chinook salmon redd in Camas Creek between Castle and Furnace Creeks. Cattle access at site. September 4, 2012.

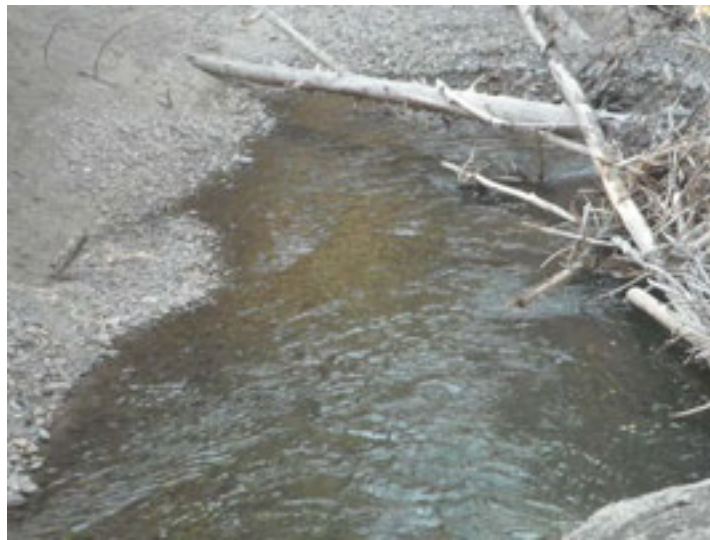
32. I again hiked this reach on September 19, and observed similar conditions. For example, I noted a Chinook salmon redd just upstream of a logjam, with cattle sign on the adjacent bank, including fresh cattle hoof prints.

Fig. 42: Logjam Chinook salmon redd in Camas Creek between Castle and Furnace Creeks. Recent cattle access at site. September 19, 2012.

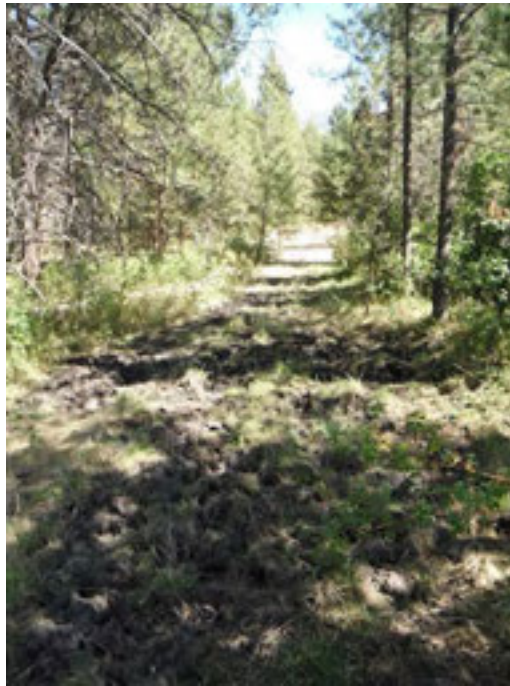
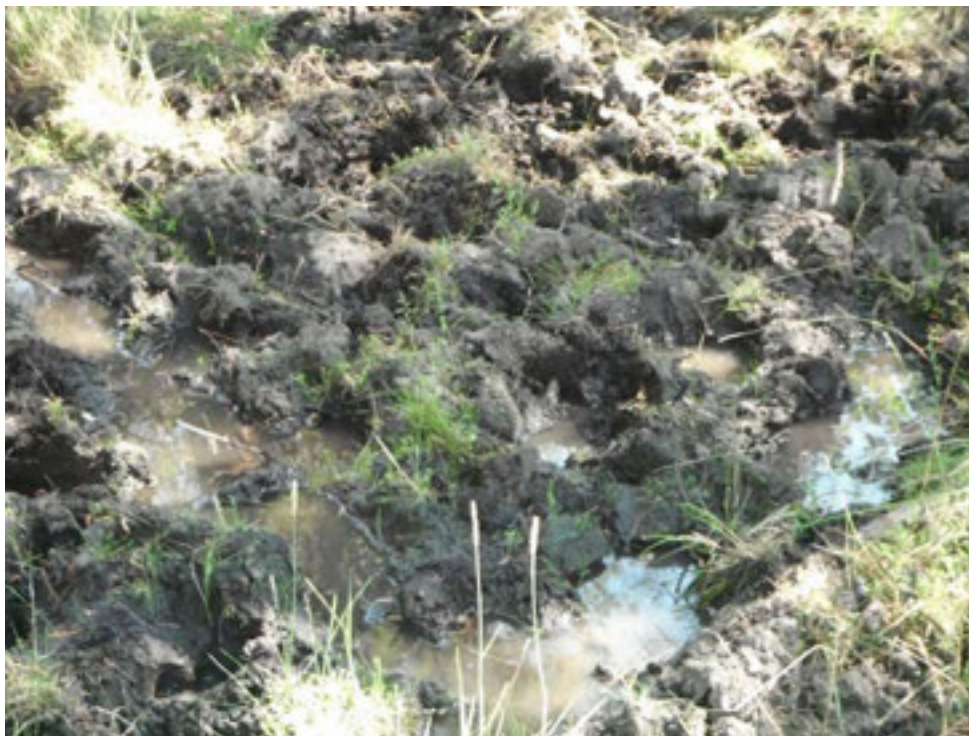
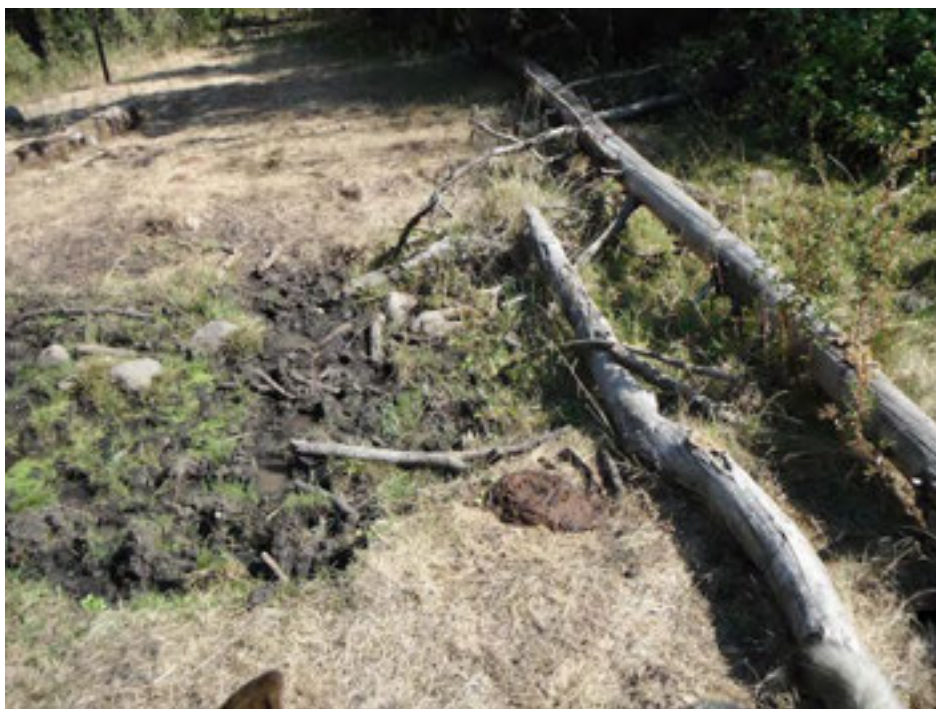
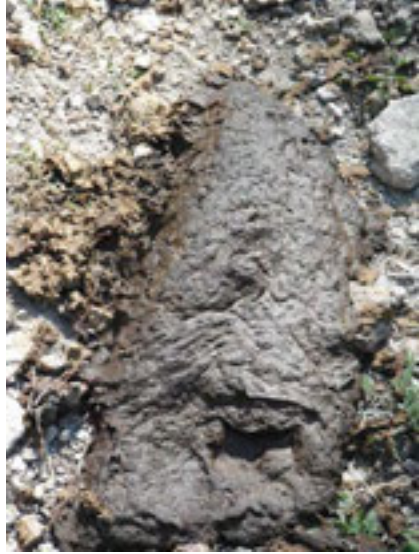
33. I hiked to the Furnace Creek drift fence on several trips. On August 17, I observed that the bench above the left bank of Furnace Creek, downstream of the Furnace Creek drift fence gate (at the trailhead for the Furnace Creek trail), was heavily impacted by cattle. There are several wet spring areas, which are tributary to Furnace Creek, that were recently and severely trampled by cattle, with hummocks, deep hoof prints, and abundant cow pies. Figs. 43–44. I also observed multiple cattle trails from this area leading down to Furnace Creek below the drift fence. I observed the same conditions on August 23, September 4, and September 19. In fact, I noticed numerous additional fresh cow pies here on September 4, indicating cattle had been below the drift fence between August 23 and September 4. Figs. 45–46.

Fig. 43: Trampled wet areas below Furnace Creek drift fence (visible in distance at end of trail in photo). August 17, 2012.

Fig. 44: Closeup of trampled wet area below Furnace Creek drift fence. August 17, 2012.

Fig. 45: Trampled wet area below Furnace Creek drift fence, with large fresh cow pie in foreground. September 4, 2012.

Fig. 46: Fresh cow pie below Furnace Creek drift fence. September 4, 2012.

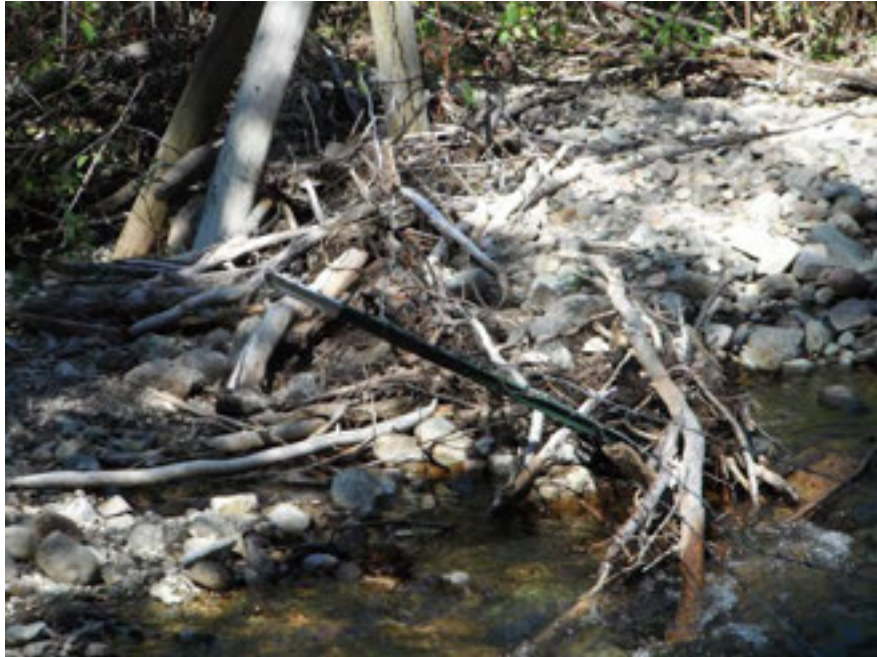
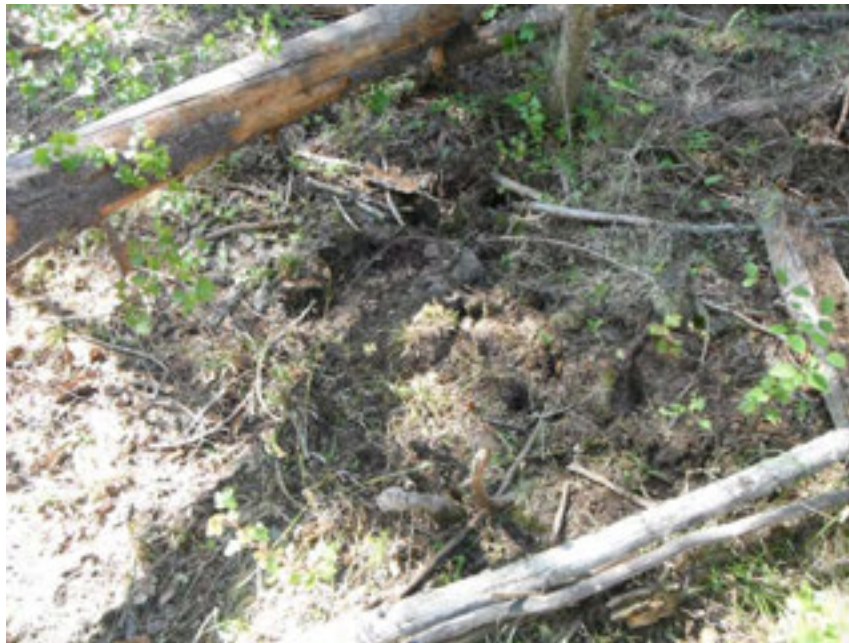
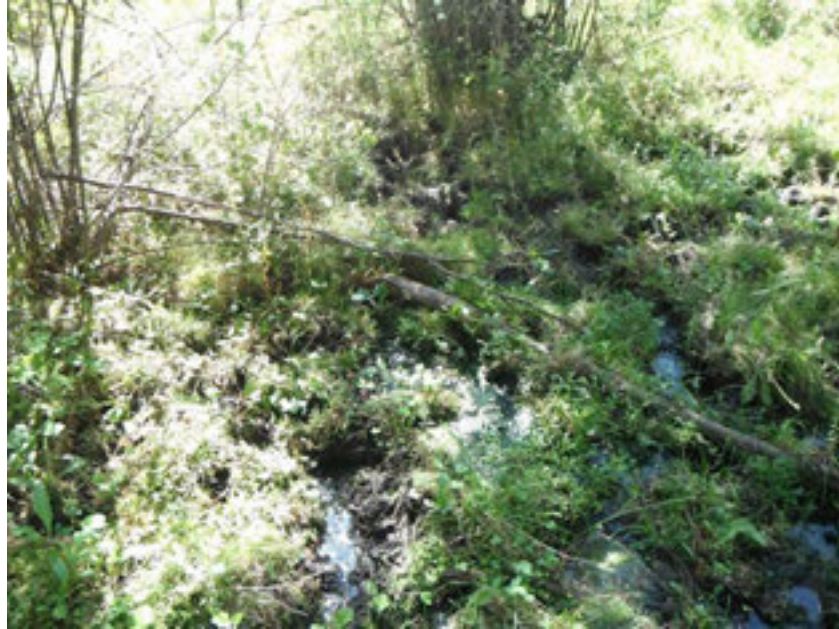
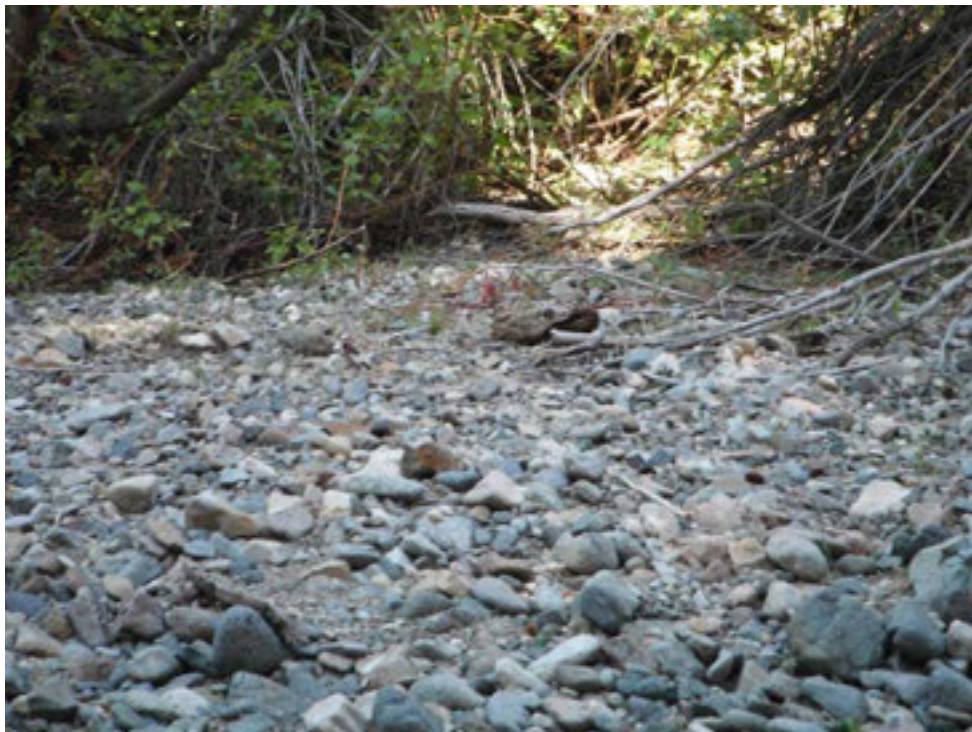
34. On August 17, I walked down the Furnace Creek drift fence from the Furnace Creek trail (left bank) to Furnace Creek. There were well-established cattle trails on both sides of the drift fence leading from the trail down the relatively steep riparian buffer to the left bank and channel of Furnace Creek. At the creek, I observed that the fence had broken and loose wires and was badly skewed and low to the ground across the creek, allowing cattle to step over it. I observed cattle sign (waste and hoof prints) in the stream channel, on the gravel bars, and in the riparian area both upstream and downstream of the fence and along both banks.

Fig. 47: Furnace Creek drift fence across Furnace Creek. August 17, 2012.

Fig. 48: Fresh cattle hoof prints in Furnace Creek riparian area (left bank), downstream of drift fence. August 17, 2012.

Fig. 49: Fresh cattle hoof prints in Furnace Creek riparian area (left bank), downstream of drift fence across Furnace Creek. August 17, 2012.

Fig. 50: Cow pie in Furnace Creek stream channel, downstream of drift fence across Furnace Creek. August 17, 2012.

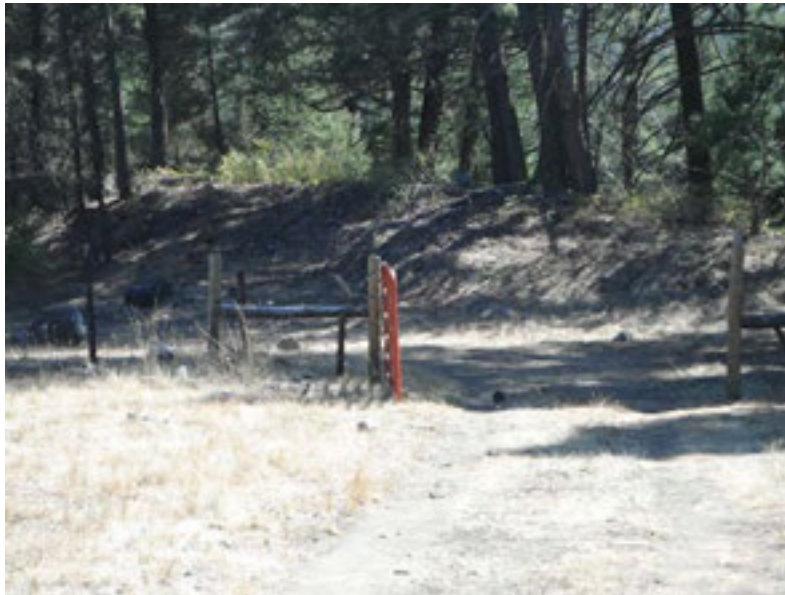
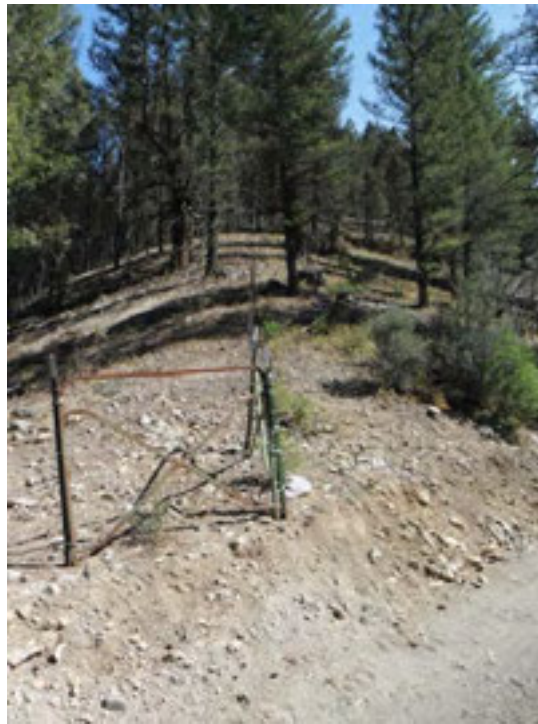
36. On August 17, I found the gate in the fence across the Camas Creek road designed to prevent cows from getting into Camas Creek upstream of Furnace Creek to be wide open. There were many cattle hoof prints in the road, indicating that cattle had recently been above the fence line.

Fig. 51: Gate across Camas Creek road at Furnace Creek open. August 17, 2012.

Fig. 52: Cow prints and eroding side-slope from hoof shear on road above Camas Creek fence at Furnace Creek. August 17, 2012.

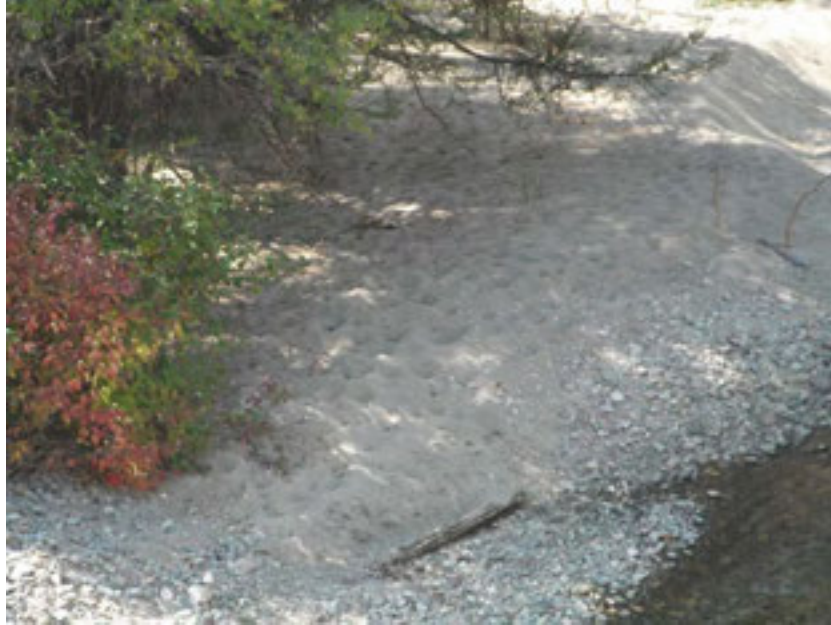
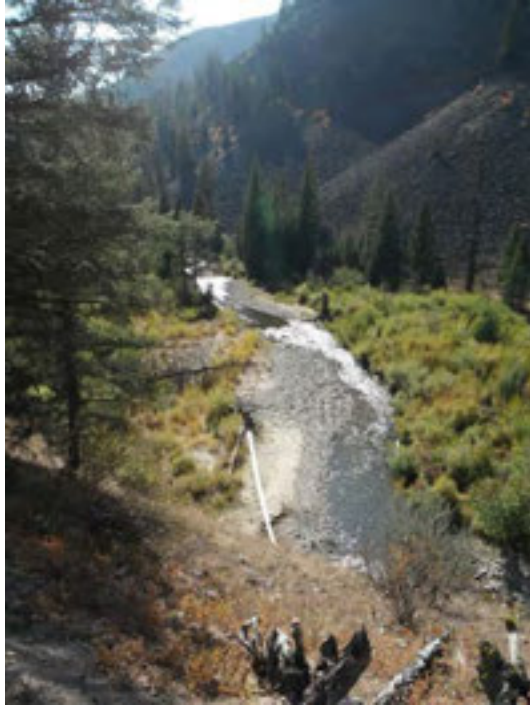
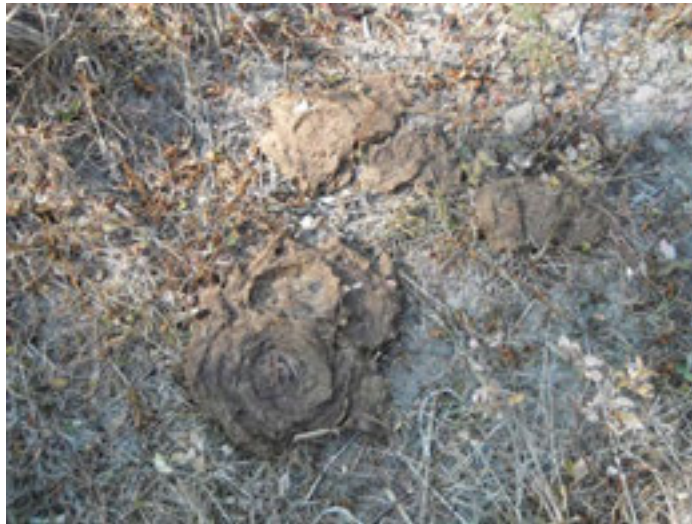
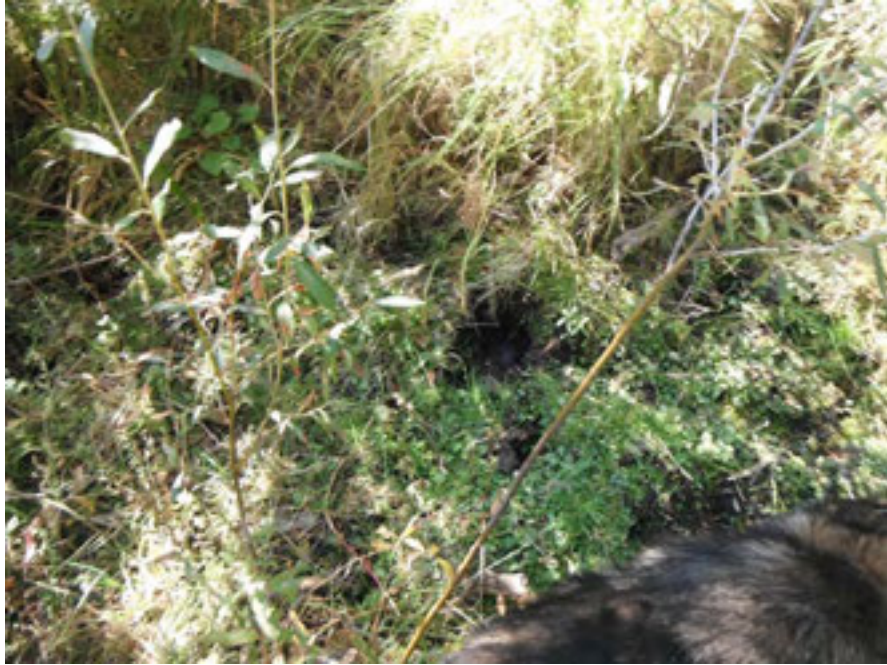
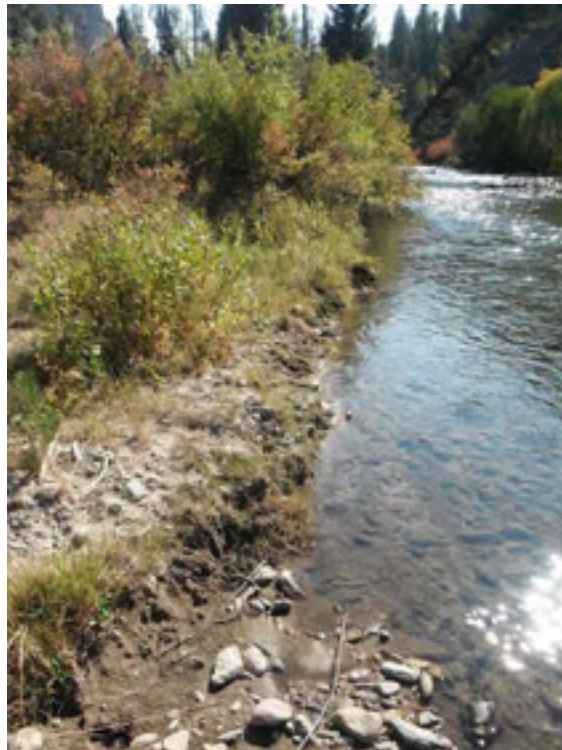
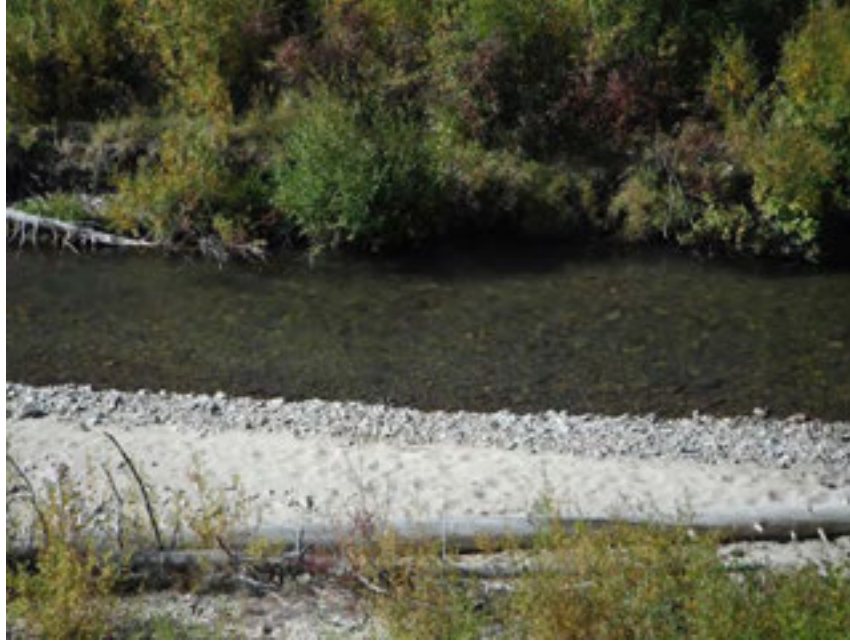
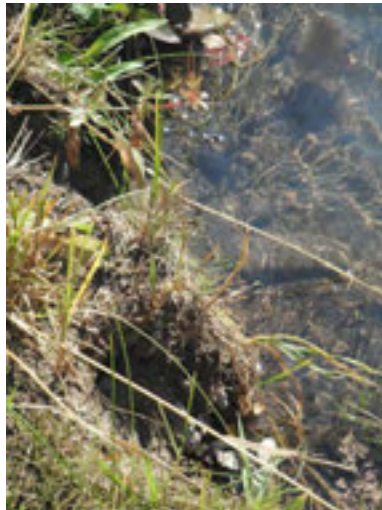
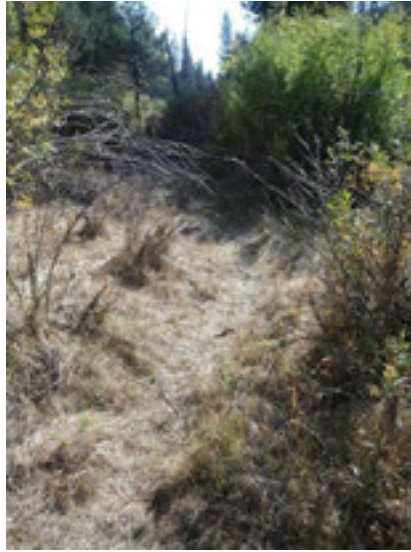
37. On September 19, I walked about one mile above the Camas Creek drift fence at Furnace Creek, towards Hidden Valley Ranch and White Goat Creek. I took several cow paths from the road and followed them through the riparian areas to Camas Creek. I observed that cattle were accessing the creek in many places in this important spawning reach, particularly in low-gradient, shallow reaches featuring cobble-gravel substrate, which are also preferred spawning habitat. I observed numerous sites where the river bank contained cattle hoof prints and waste. I also observed evidence that the cattle were crossing the creek (i.e., cattle sign on both sides of the bank). Interestingly, the cattle sign along the banks was largely not visible from the Camas Creek road, only becoming visible when I walked through the often densely-wooded riparian areas to the bank. Some of the hoof prints and cattle waste were relatively fresh and from this year. Photographs of this reach follow.

Fig. 53: Cow hoof prints along Camas Creek right bank, about 0.5 mile upstream from Furnace Creek). Several Chinook salmon redds adjacent to this site. September 19, 2012.

Fig. 54: Camas Creek, about 0.5 mile upstream from Furnace Creek. Cattle prints and waste on bank in lower right of photo, and Chinook salmon redds in this reach. September 19, 2012.

Fig. 55: Camas Creek vista about 0.75 miles upstream from Furnace Creek, showing the flat, low-gradient water that is ideal Chinook salmon spawning habitat. September 19, 2012. Several redds in this reach, as well as recent cattle sign. Closeups of this reach follow.

Fig. 56: Cow pies from this year in riparian area adjacent to descending right bank of Camas Creek, upstream of Furnace Creek. September 19, 2012.

Fig. 57: Hoof prints in Camas Creek riparian area. Photo is close-up of Fig. 55. September 19, 2012.

Fig. 58: Hoof prints and bank damage on Camas Creek, in an area with Chinook salmon redds. Photo is close-up of Fig. 55. September 19, 2012.

Fig. 59: Cattle hoof prints in Camas Creek streambank. Photo is close-up of Fig. 55. September 19, 2012.

Fig. 60: Closeup of cow hoof prints along Camas Creek, downstream of White Goat Creek. September 19, 2012.

Fig. 61: Typical cow trail leading from road to Camas Creek, downstream of White Goat Creek. September 19, 2012.

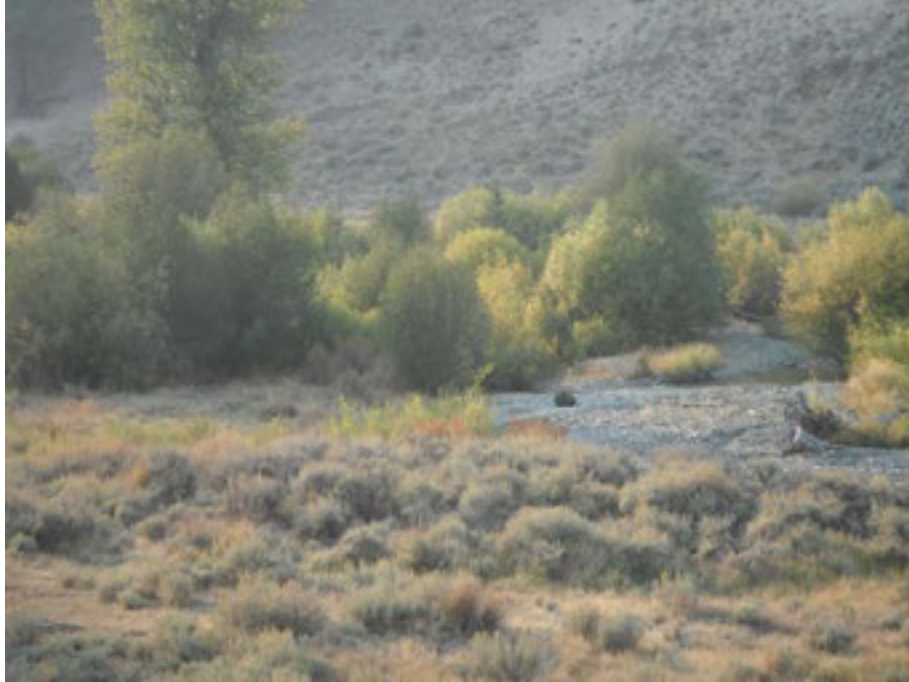
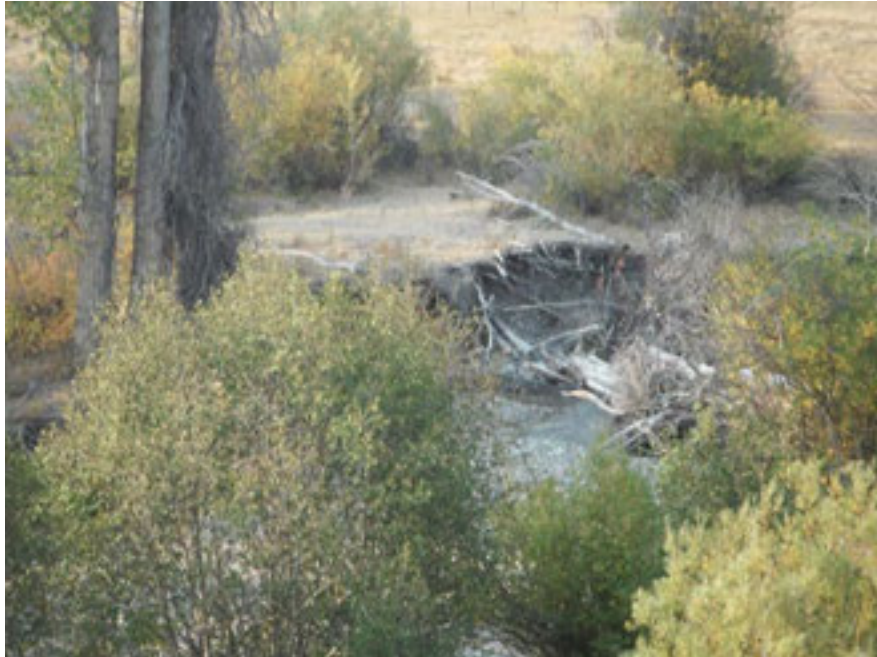
38. On September 19, I traveled about a mile up West Fork Camas Creek's confluence with Camas Creek to observe riparian conditions. There is an enclosure in this reach with numerous wire gates that allow cattle access into the riparian area, if opened or breached. It was apparent that this is occurring, because similar to Camas Creek above Furnace Creek, I observed cattle sign in the riparian areas which was hard to detect from the road. I observed numerous cattle paths crossing the riparian areas, with the paths leading to the creek. Where the cows were reaching the creek, adverse impacts were present including hoof prints, bank damage and erosion, soil hummocking, and cattle waste.

Fig. 62: Overview of riparian area laced with cow trails, lower West Fork Camas Creek. September 19, 2012.

Fig. 63: Cattle use in lower West Fork Camas Creek riparian area: heavily grazed riparian bench, with collapsing bank. September 19, 2012.
